## LuK Service Info

# Features of gearbox installation

## Clutch disc failure

Models: Jumper II, Ducato, Boxer

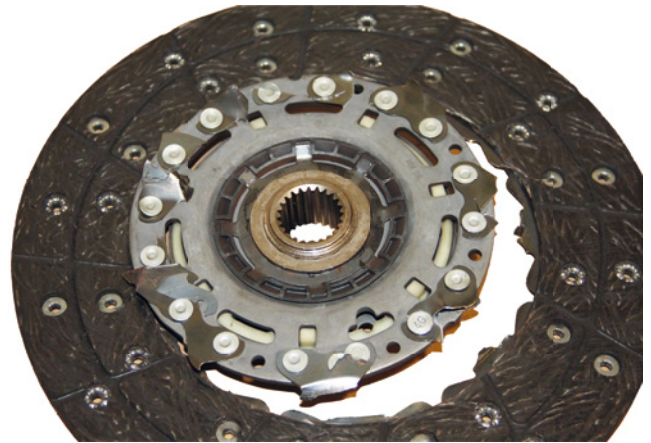
Image 2: Broken clutch disc hub

Errors during car repairs can lead not only to decreased driver comfort and shortened service life parts, but in some cases to significant damage of components. One of the common malfunctions of listed above LuK RepSet, which are installed on Citroën, Fiat and Peugeot 2.3 and 3.0 diesel engines, is a broken clutch disc hub (Image 1). The driver has gear shifting problems. These symptoms usually appear during the mileage 2000 - 20.000km after clutch replacement. In these engines the alignment dowels on the cylinder block, which determine the gearbox bell housing relative to the engine block, are located relatively close together (Image 2).

To prevent the disc hub from being turned off or the ring-shaped leaf spring being damaged or displaced after replacing a clutch, it is important to follow the special procedure for installing the gearbox on the engine. Once the gearbox has been fitted and the central actuator bled, the next steps involve loosening and retightening the gearbox bell bolts while depressing the clutch pedal. This order is described in more detail in the manufacturer's instructions. In addition, new centering pins must be used and not allowed to become deformed or compressed.

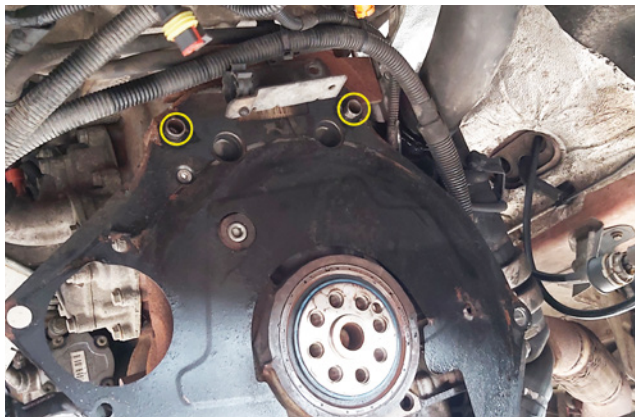
Image 1: The alignment dowels on the cylinder block

The alignment pin grooves should be vertical at the bottom to prevent moisture accumulation. Only installation carried out in this way guarantees parallel and angular alignment of the units, as well as long-term operation of the replaced parts.
