## LuK Service Info

# Complaints regarding the double clutch

## Possible handling issues and error memory entries

Gearbox: DQ /Generation

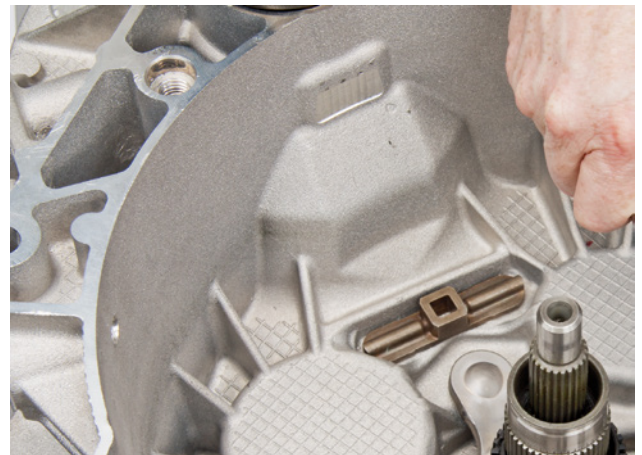
Figure 1 : Hinge bearing of the large engagement lever

In Volkswagen Group vehicles that are equipped with a second-generation dry double clutch transmission, the bonding of the gearbox-side hinge bearing of the large engagement lever (figure 1) may become loose during the operating life.

- The vehicle judders/rattles when pulling away or during automatic gear changes from first to second gear.
- The malfunction display for transmission errors on the dashboard lights up intermittently.
- The gearbox switches to emergency mode; only gears 1, 3, 5 and 7, or 2, 4, 6 and R can be used.

- Is the hinge bearing parallel to both contact surfaces in the gearbox housing and is there full-surface contact?
- Is the hinge bearing firmly bonded in its installation position such that it cannot be moved?

If the hinge bearing fails to meet one of these criteria, a repair measure is required.

If a hinge bearing is loose or not parallel to the contact surfaces, proceed as follows:

1. Remove the hinge bearing using commercially available pliers (for example: water pump pliers) and a back-and-forth motion.
2. Thoroughly clean the alignment holes in the gearbox-housing using garage equipment.
3. Thoroughly clean the rear of the hinge bearing using garage equipment. Then apply liquid locking agent (spare part numbers: D 000 600 A2, D 154 103 A1 or AMV18800102) to the rear of the hinge bearing at the contact surfaces.
4. Reinsert the hinge bearing into the gearbox housing. Using a hammer and a suitable auxiliary tool (for example: a copper mandrel, an aluminum mandrel, or a piece of wood), carefully drive the hinge bearing into the gearbox housing as far as it will go. To do this, alternately strike the left and right sides of the hinge bearing.
5. Continue driving in until the end stop is audible.
