Overheating on rotor shaft bearing due to increased exhaust back pressure and oil coking on compressor wheel

Vehicle Manufacturer: BMW

Vehicle: X3 (E83) 2.0 d, 520 d (E60, E61)

Engine code: M47 D20 (204D4), 150 bis 163 PS

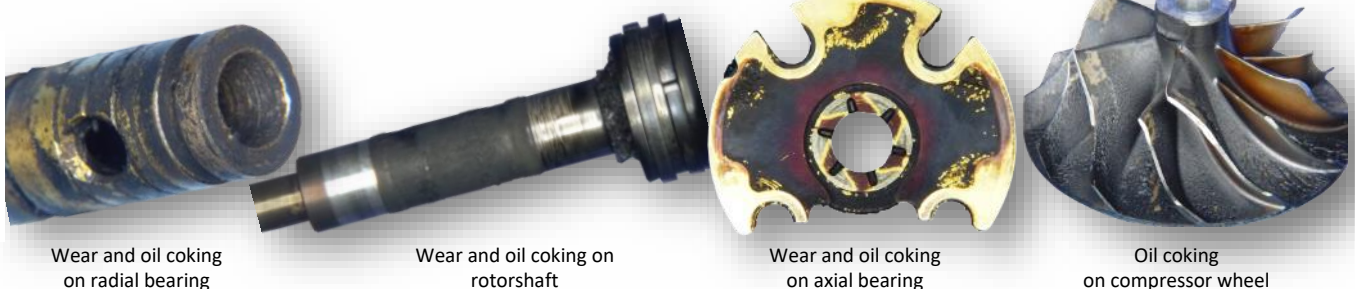
Turbochargers on these vehicles are often damaged due to increased exhaust back pressure. However, they often do not show the typical increased axial bearing clearance.

The hot exhaust gases which are entering into the bearing housings cause oil coking on the axial bearing. The wear which occurs on the radial bearing at the turbine side forces the wheels to brush against their respective housings. The wear signs of wear often show later at the axial bearing. Very conspicuous is the coking on the wings of the compressor wheel, which in this case is not caused by oil contamination from the crankcase ventilation. Due to the jam of exhaust gases and the therefor increased temperature of the components a significant coking is to be recognized on the wings of the compressor wheel.
