Failure of turbocharger, weak performance, loud noises, heavy smoke development, oil leakages, increased bearing clearance

Vehicle Manufacturer: VW, AUDI, SKODA

Vehicle: Passat, A4, A6, A8, Allroad, Superb

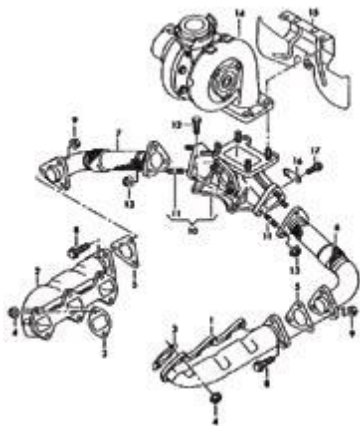
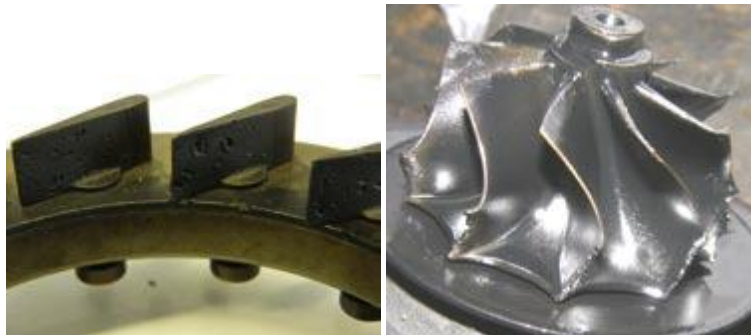
Warning: Exhaust manifolds made from welded steel sheets were installed in these vehicles. Under certain conditions the inner steel sheet or the compensator pipe may break.

These broken pieces from the exhaust manifold and the compensator pipes may act as foreign bodies on the turbine wheel and the guide vanes of the VTG. Both parts will be destroyed as a consequence.

An increased bearing clearance is a consequential damage resulting from the foreign body damage. Ein erhöhtes Lagerspiel ist ein Folgeschaden, der durch den Fremdkörper verursacht wurde. Please, therefore, check the gas inlet edges of the turbine wheel.

A visual check is possible from the turbine outlet onto the turbine wheel vanes in good lighting conditions.

With a damage like this, the exhaust manifolds have to be exchanged!
