Blue Print

ADM58226, ADM58230,
ADM58233C, ADM58236,
ADM58333, ADM58943,
ADM58944

To fit: Mazda 3 (BK), Mazda 5 (CR), CX-7 (ER), CX-9 (TB), MX-5 (NC), RX-8 (FE)

Wheel Bearing Kits

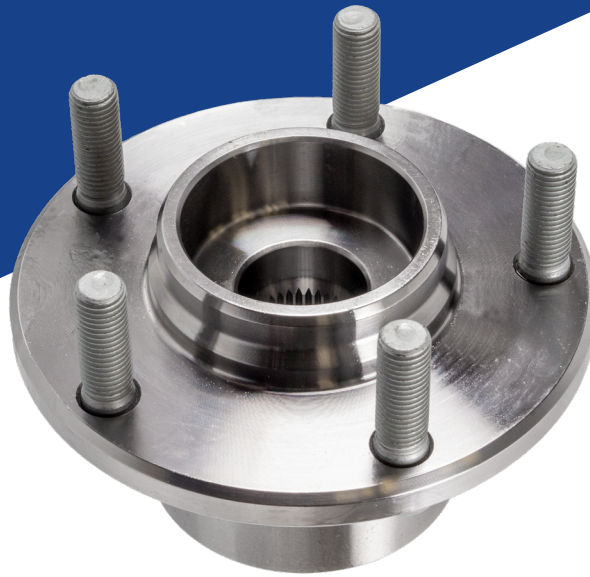
After the installation of a new wheel bearing or CV joint the vehicle emits a click/clunk type sound when moving either forwards or backwards from a stationary position.

The noise is a result of a small amount of movement between the wheel bearing/drive flange and the outer CV joint.

Thoroughly clean the mating surface between the wheel bearing/drive flange and the outer CV joint using a suitable degreaser. When the mating surface has been degreased apply a light coating of molybdenum grease (Blue Print ADBP550000) between the two surfaces and reassemble using a new hub nut.

Be careful not to get grease on the brake disc or pads.
