SWAG 30 94 0308

To fit:
various Volkswagen, Audi, SEAT and Škoda models

Repl. no. 03L 903 137 T S1

Auxiliary belt kit with belt tensioner and bolt

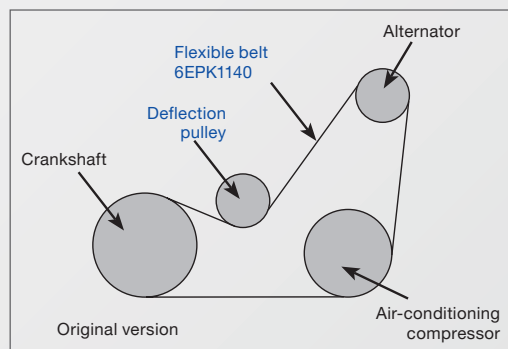
Figure 1

There is a squeaking/'humming' noise coming from the auxiliary drive area of the vehicle, the auxiliary belt is damaged, and the engine may not start.

The original version of the auxiliary belt drive was driven by an elastic multi-V belt and a deflection pulley which suffered from wear, leading to insufficient tension of the auxiliary belt. (Fig 1) To improve the NVH (noise, vibration, harshness) characteristics, the vehicle manufacturer redesigned the components of the auxiliary belt drive.
