Engine DW 10 F  
Engine DW 12 R

VKMC 03317  
VKMA 03317, VKPC 83646

## Case study DW 10 F and DW 12 R engines

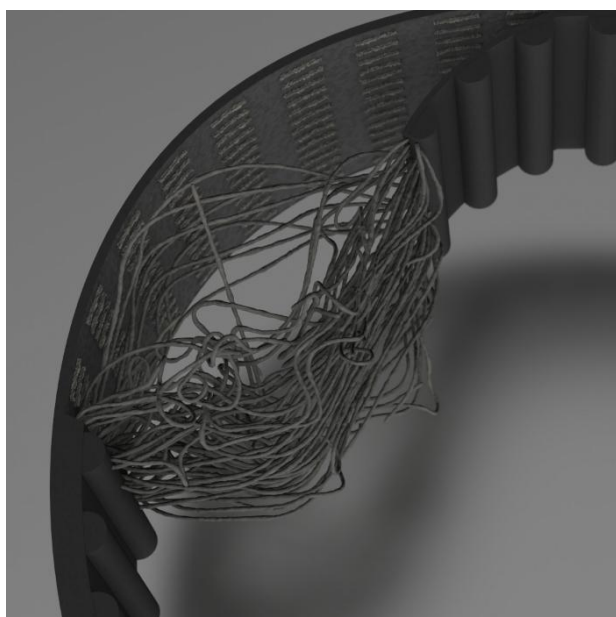
We have investigated a number of complaints where the coolant pump impeller has moved on the shaft scratching the coolant pump housing, or where the timing belt teeth have partially sheared off.

Belt teeth partially sheared off.

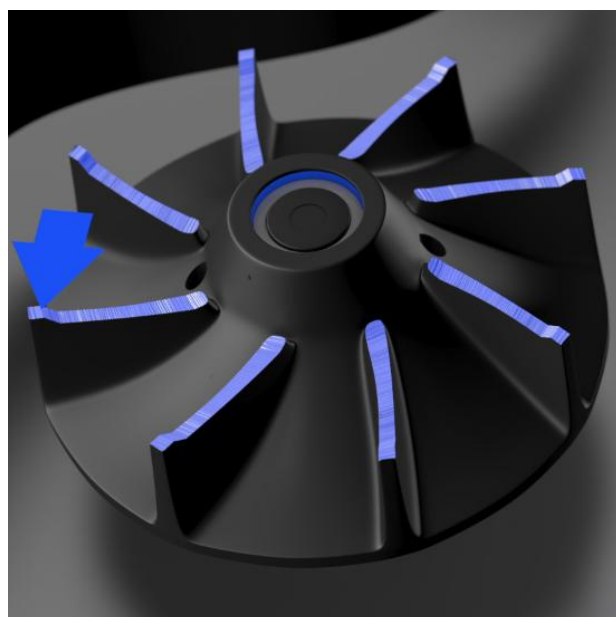
Impeller wheel on the shaft displaced, vanes ground off.

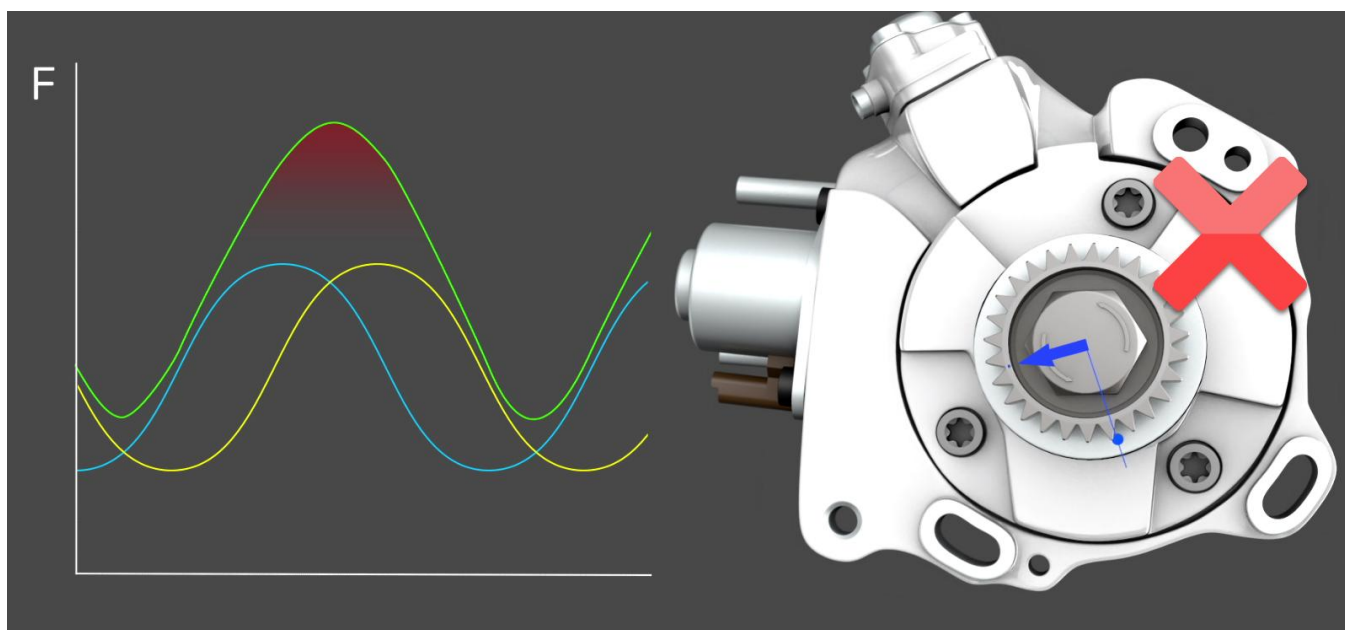
There are markings on the gear wheel and the housing of the high-pressure pump which are aligned with each other when correctly adjusted. If these markings are not aligned in the setting position of the engine, the vibrations of the combustion engine and the high-pressure pump add up, resulting in increased overall vibration of the timing belt drive.

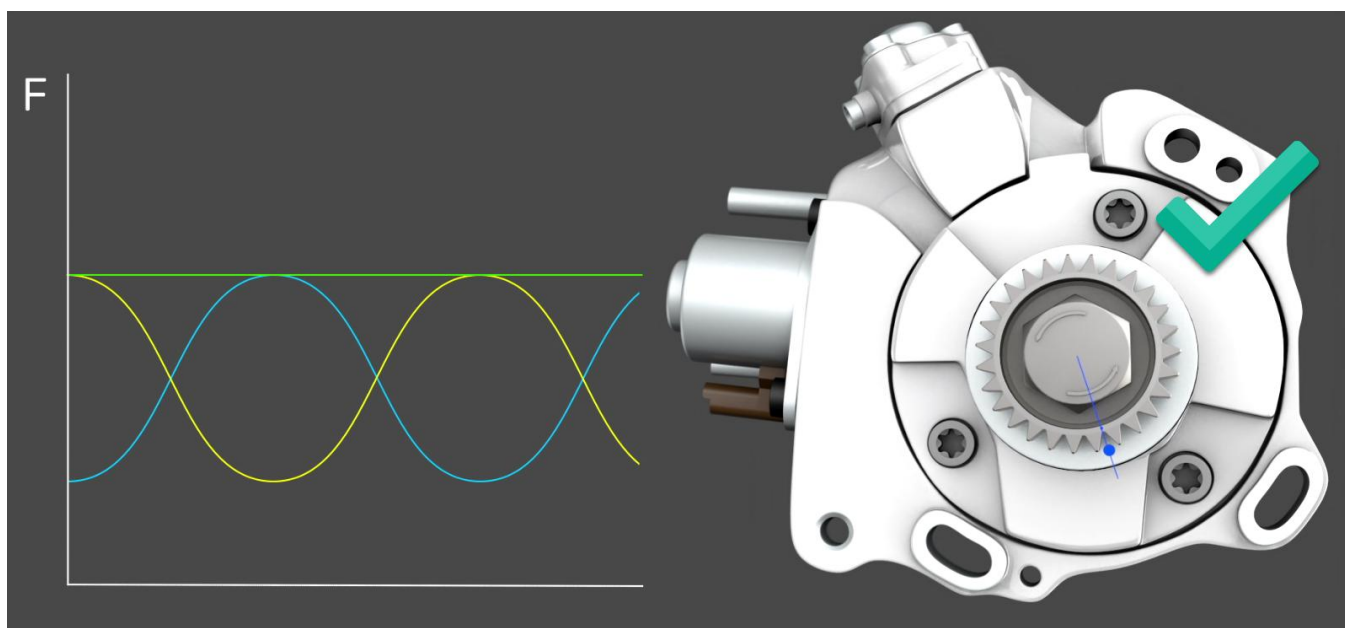
If the markings are on exactly the same level, the pump is correctly synchronized with the combustion engine and the oscillations balance each other out so that the overall oscillation is permanently within tolerance.

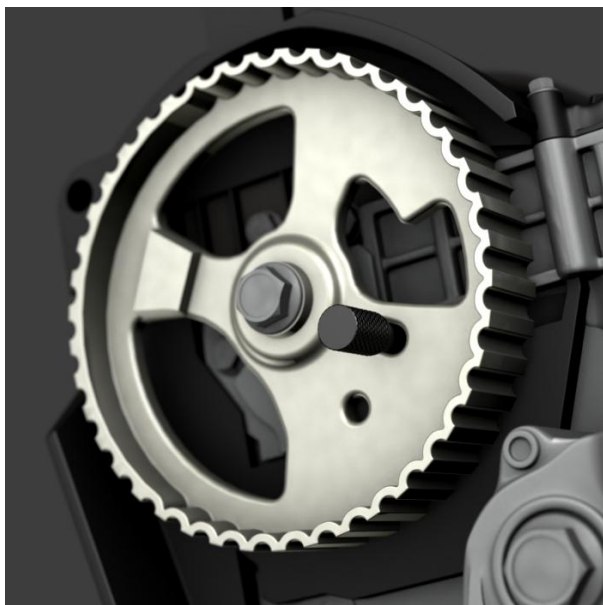
Timing belt / TDC:  
Slotted hole in 4 o'clock position

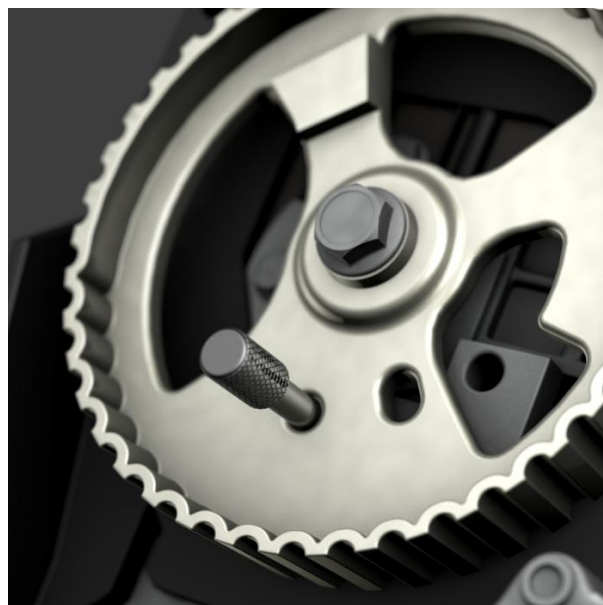
High pressure pump setting:  
Small hole in 6 o'clock position

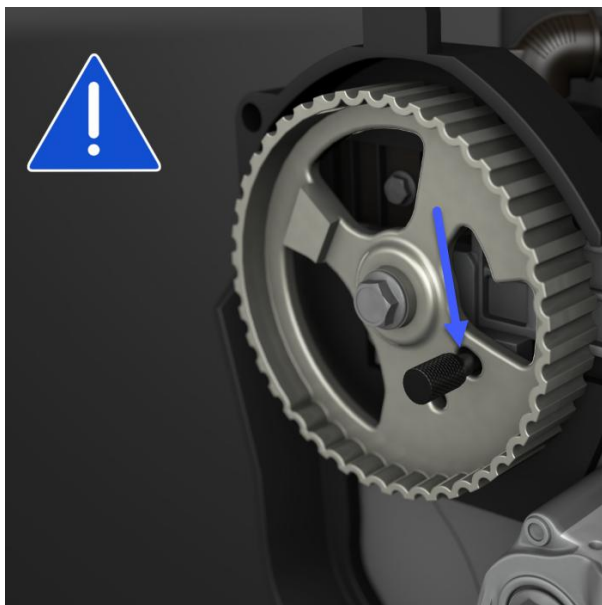
Camshaft and camshaft sprocket locked  
Slotted hole in 4 o'clock position

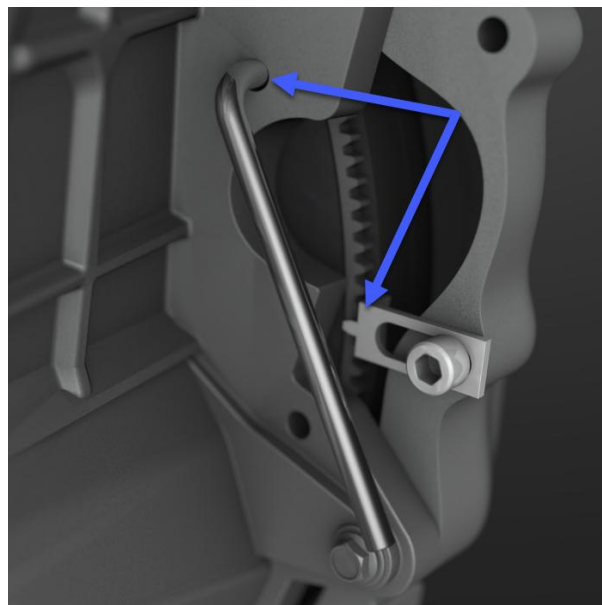
Crankshaft blocked via flywheel
