## SWAG 33 11 0488

Mazda CX3 2015>, CX5 I 2011 > 2016, CX5 II 2016>, Mazda2 III 2014 > 2022, Mazda3 III 2013 > 2019, Mazda6 III 2012>, MX30 2020>

## Ignition Coil

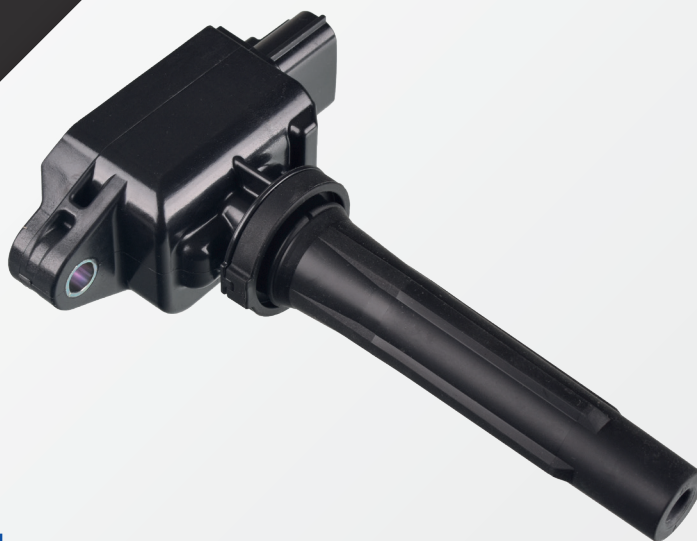
Vehicle symptoms include a lack of engine power and an inconsistent idle, combined with the engine malfunction indicator lamp being illuminated on the instrument cluster. Engine Control Unit (ECU) diagnostics will reveal the following possible fault codes:

Over time the insulation found between the primary and secondary coil windings is degraded by heat and vibration. This deterioration causes fractures to form in the secondary coil windings, leading it to overheat and fail, resulting in a misfire.

Note: There is a known issue which affected some pre-2017 vehicles fitted with ignition coils manufactured by Yumebishi.

First, use suitable diagnostic equipment to identify which ignition coil is causing the misfire. Alternatively, this can be diagnosed manually by removing each spark plug and systematically testing the coils to establish which is not firing correctly.

Each ignition coil is required to provide a high voltage to bridge the electrode gap. If the ignition coil insulation is degraded, additional load will be placed upon the system. Therefore, when the faulty ignition coil has been identified, it is wise to check the condition of the plugs themselves as they too can deteriorate with age, further increasing the load on the system.

Disconnect the battery and replace the failed ignition coil (or coils) with SWAG Ignition Coil 33 11 0488 and spark plugs as necessary. Finally, reconnect the battery and clear any fault codes using a suitable diagnostic tool.
