TECHNICAL REPORT

1.0 1.2 EB PureTech engines:
features, problems and repair

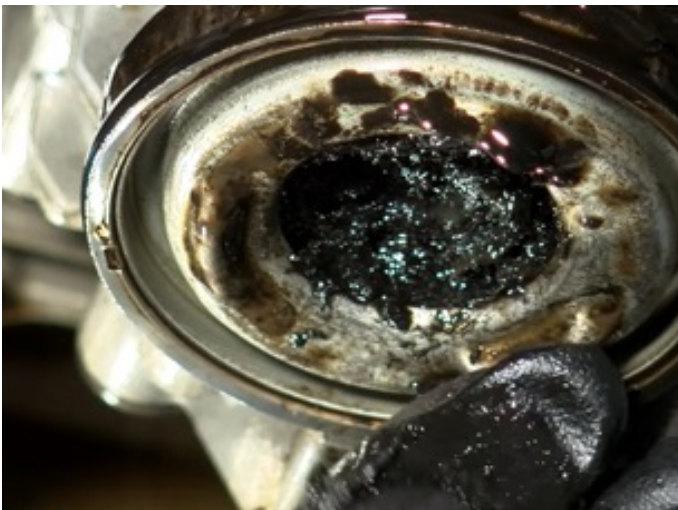
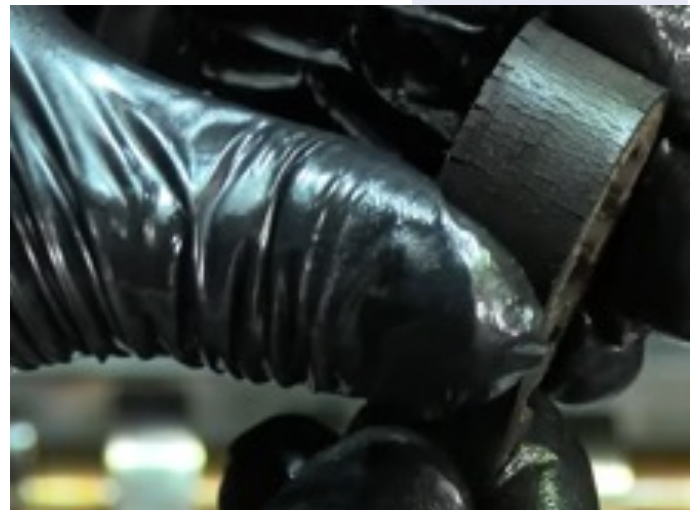
It has been detected that on some PureTech engines, especially those on short journeys, the timing belt is deteriorating prematurely.

The **oil becomes contaminated** by fuel residue, which affects the integrity of the belt. This debris from the belt can leak into the lubrication ducts and saturate the oil filter.

The solution to these problems is based on **preventive maintenance** of the lubrication circuit, changing filters and oil every few km or in the period of 1 year, whichever comes first.

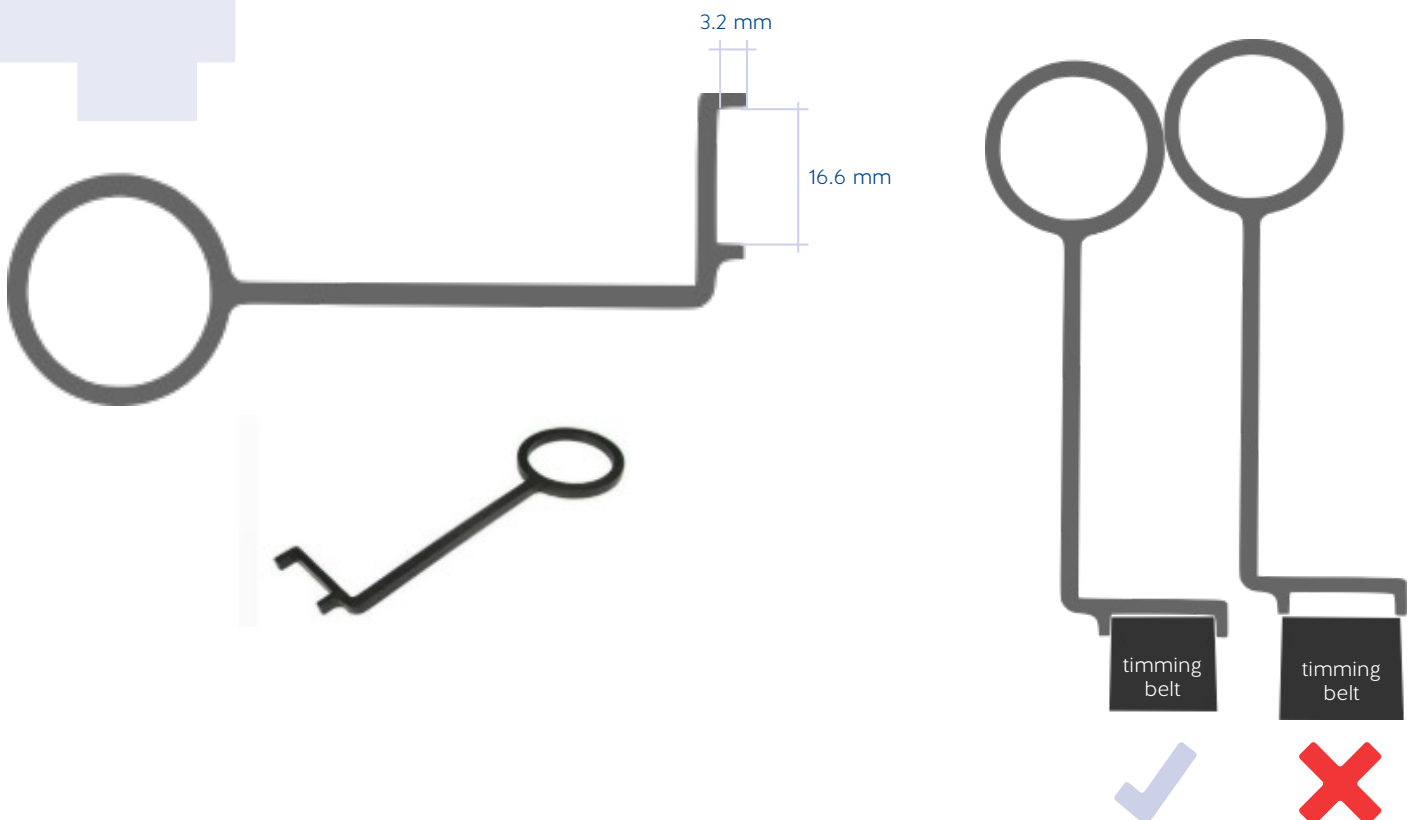
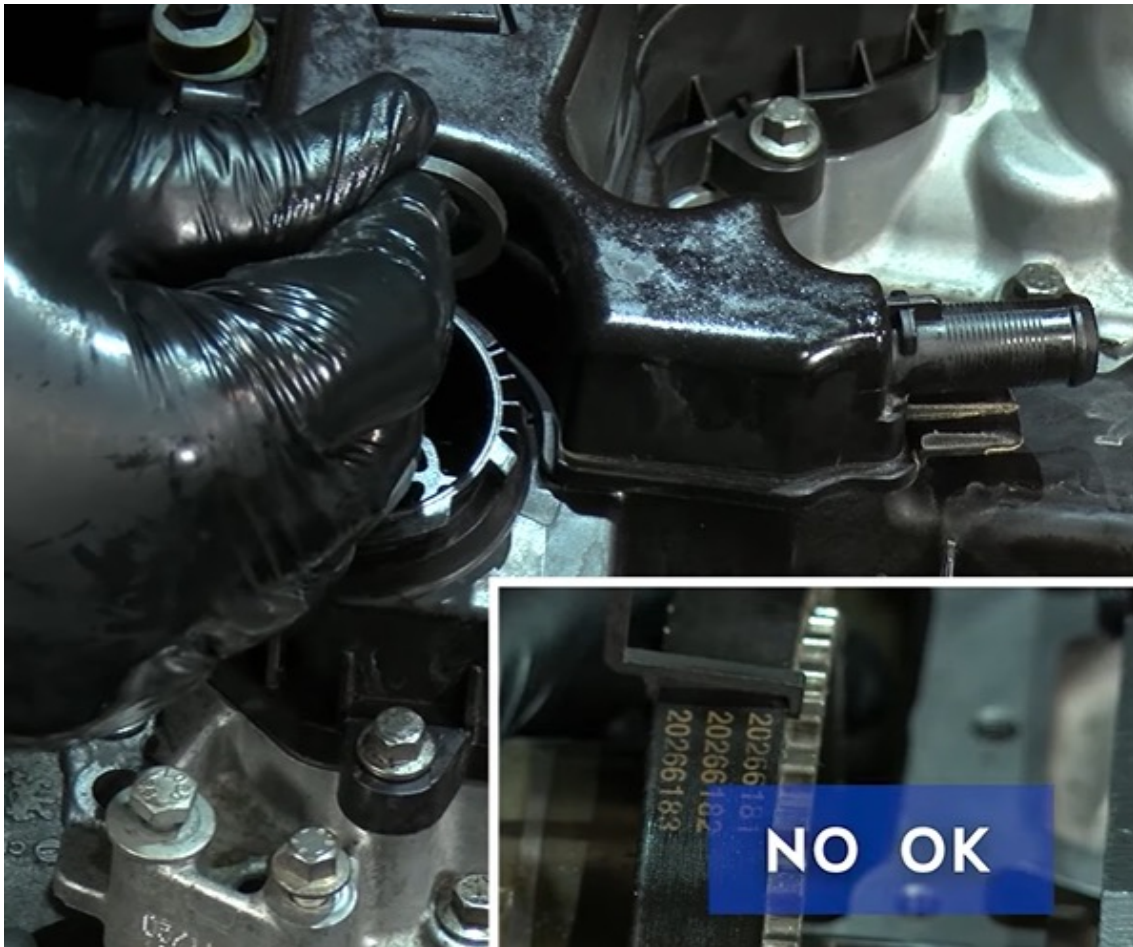
If the belt is found to be affected, it will be wider, indicating that it is time to replace it before premature failure.

The brand's recommended maintenance schedule calls for the belt to be replaced every **six years or 100,000 km**. However, it is possible to check the condition of the belt with a pass-fail tool through the oil filler cap.
