SI-210819

Service-Information Turbocharger

Lack of power, noises, fault boost pressure control Foreign body damage on the exhaust or the intake side

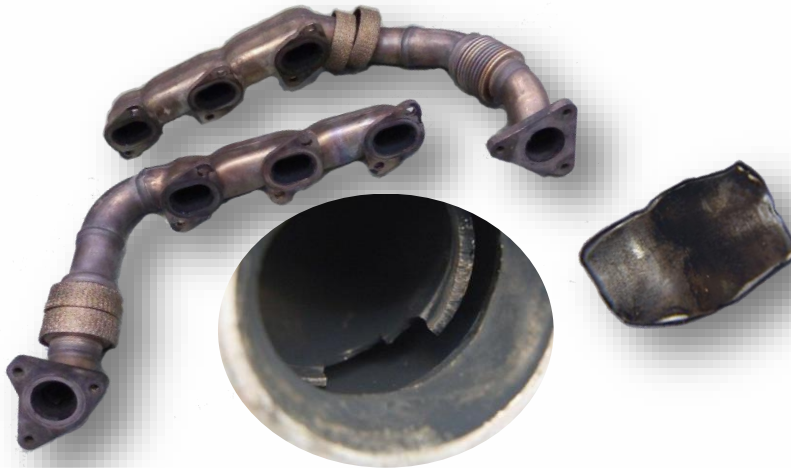
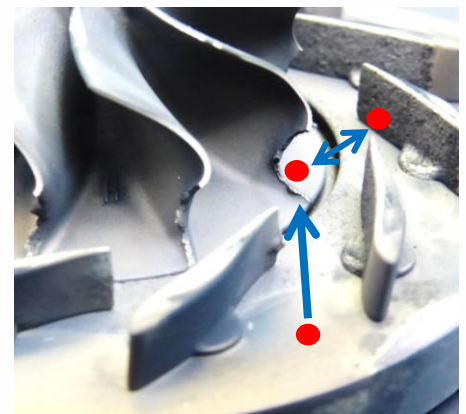
It is noted that in these vehicles the turbochargers often fail with faulty boost pressure control and fault memory entries of the electric actuator.

The cause of the failure of the turbocharger is often found in the air gap isolated exhaust manifolds. Resonance vibrations and rapid temperature changes lead to material fatigue with cracking and eruptions. These foreign objects destroy the gas inlet edges of the turbine wheel and the VTG unit.

The exhaust manifolds and their compensation tubes must be replaced on both sides. The exhaust ports of the cylinder heads and the entire EGR tract are to be inspected for foreign bodies.

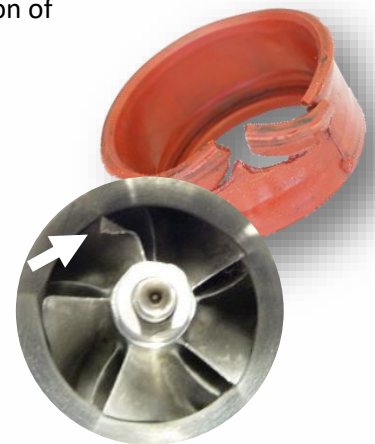
Softened or damaged seals at the suction of the compressor housing cause suction of foreign body damage, which lead to noise and power loss of the turbocharger.

These seals are softened by oil vapor in the crankcase breather. For general maintenance, these seals are often damaged when the intake pipe is fitted.

This seal must always be renewed when replacing the turbocharger.
