SI 1066
For technical personnel only!
1/1

SERVICE INFORMATION

RATTLING NOISES

DUE TO OIL SLUDGE IN THE VACUUM PUMP

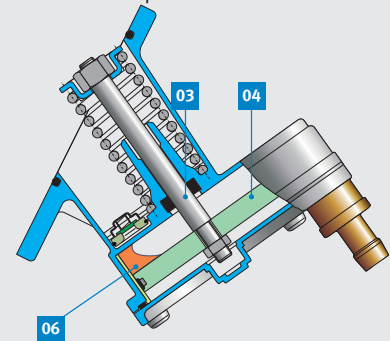
Fig. 2:
Installation position VW LT and T4

The piston vacuum pump is driven by the camshaft (01) through a connecting tappet (02). In the recommended installation position, the engine oil can flow back into the engine (Fig. 1). The installation position in the VW Transporter is as shown in Fig. 2.

If oil is not changed regularly, the engine oil ages. Oil sludge with viscous consistency builds up between piston crown and housing. This prevents the piston from reaching its end position. There is leeway between tappet and connecting tappet. This results in rattling noises, which sound like bearing damage on the crankshaft.

In case of oil sludge deposits the vacuum pump must be replaced. It cannot be cleaned, as the vacuum pump cannot be opened with ordinary tools and there are no spare parts.

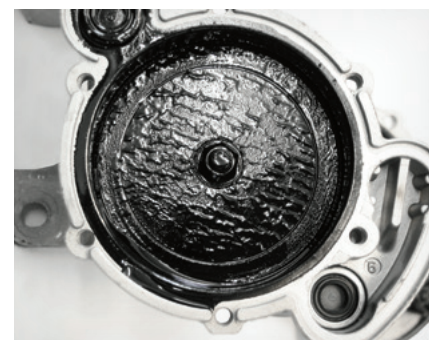
- Intervals for changing oil not adhered to
- Insufficient quality of engine oil
- Soot formation due to unclean combustion
- Faulty exhaust gas recirculation

Fig. 3: Oil sludge in the vacuum pump of the VW Transporter results in rattling noises
