SWAG 33 11 0349

To fit: Various Volkswagen, Audi, SEAT,
Škoda and MAN models.
1.6 & 2.0 TDI engines

Water Pump

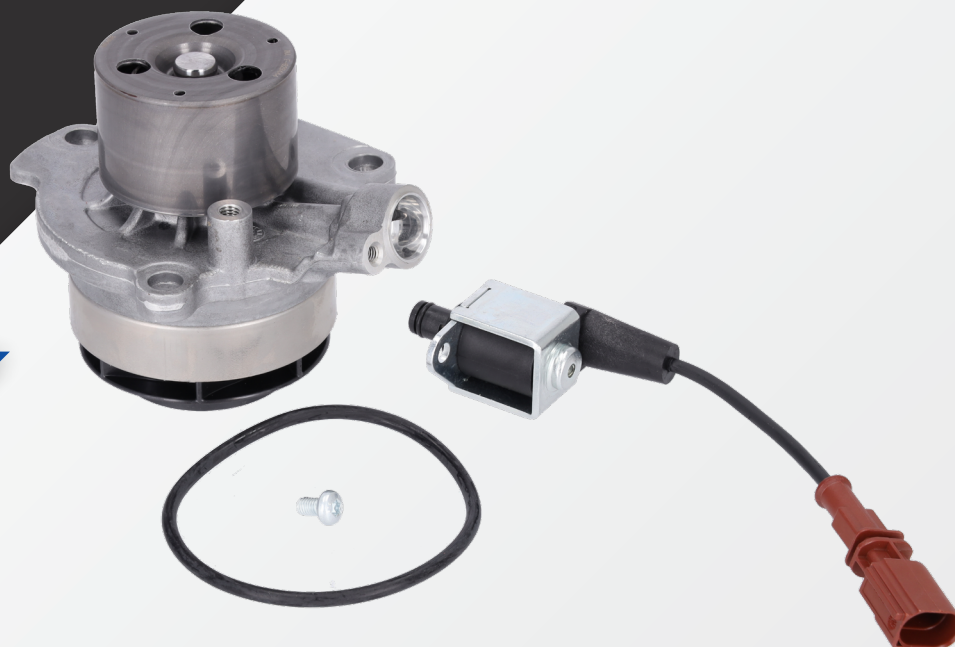
Engine overheating, coolant temperature gauge reading over 110° C, poor interior heater performance. Cooling system fault codes may also be logged in the engine control unit.

The water pump fitted to these vehicles has an ECU-controlled collar which interrupts the coolant flow to make the engine more thermally efficient. However, the control collar can become seized, the plastic impeller can break up, or the impeller can come away from the shaft.

Ensure the engine is cool, then remove the coolant filler cap. Remove the small pipe to the coolant header tank and hold this over the filler neck of the header tank; there should be a small trickle of coolant flowing with the engine at idle. This should increase in flow when the engine speed rises. If it does not, this would suggest a faulty water pump.

Replace the defective water pump with SWAG replacement part 33 11 0349. This part has an improved control collar design which has been significantly tested to eliminate the potential failure of the original water pump.

Assemble the water pump with the new solenoid valve and seals, both provided in the kit.

Fill the cooling system with the correct coolant, then vacuum bleed the cooling system. Finally, using a suitable serial diagnostic tool, carry out the cooling system bleeding procedure to expel all the air from the cooling system.
