SWAG 10 10 7574

To fit:
various Mercedes-Benz models

Cable for camshaft sensor

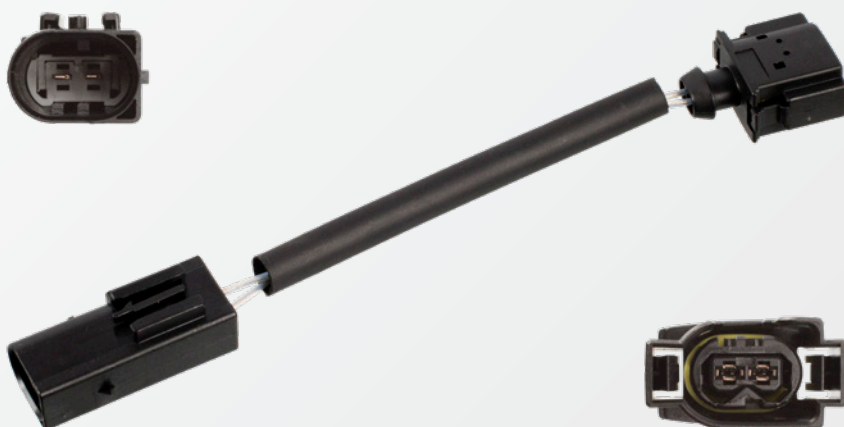
The engine management warning lamp is illuminated, with various fault code entries - referring to the oxygen sensors - logged in the engine control unit.

A malfunction of one - or both - of the oxygen sensors, due to the capillary action of the engine oil reaching the engine wiring harness. In turn, this affects the sensors via the camshaft-control solenoid valve.

Check all oxygen sensors for oil ingress and replace if necessary.

Check all camshaft-control solenoid valves for oil leaks and replace if necessary.

Locate any other contamination caused by loss of engine oil, and carry out any necessary repairs.

Install adaptor cable set 10 10 7574 between the camshaft-control solenoid valve and the engine wiring harness. The fine copper sleeves incorporated into this adaptor cable prevent the oil from spreading, reducing the risk of future electronic failures. It is recommended to install one adaptor cable for each camshaft-control solenoid valve fitted to the vehicle.

Check the engine oil level according to the manufacturer's specifications, and correct if necessary.
