**Weak performance of turbocharger and whistling noises right after installation!**

**Vehicle Manufacturer:** Renault, Nissan, Volvo, Mitsubishi

**Engine Code:** S40I, V40, Carisma, Laguna, Megane, Espace, Primera

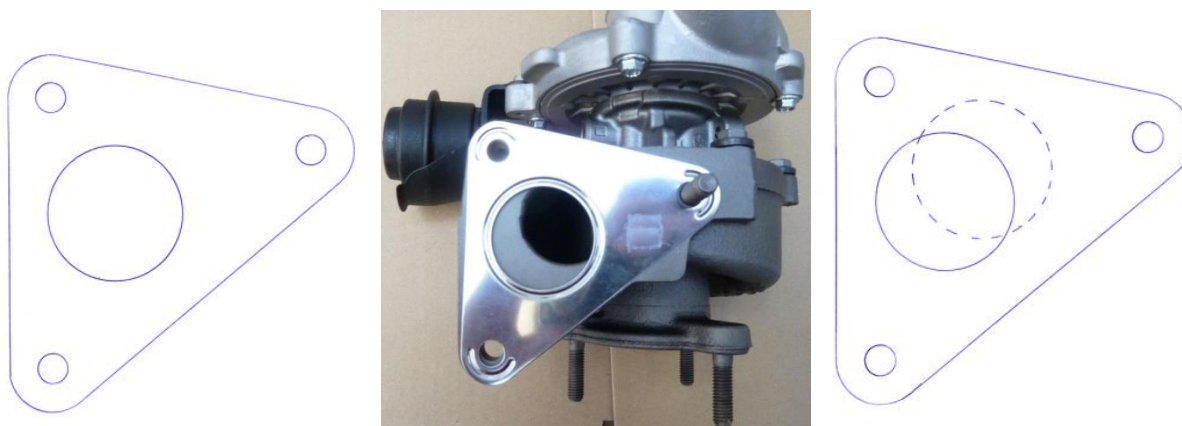
This gasket can easily be placed in the wrong direction, see picture and image with dotted line. This will lead to instant drop in performance and whistling noises.

When installing this turbocharger please have a closer look at the gasket between exhaust manifold and turbocharger!
