Loss of power, boost pressure error or noises caused by broken EGR control valves

Vehicle Manufacturer: Audi, VW

Vehicle: A4, A6, A8, Q7, Touareg, Phaeton 3.0 TDI
A6 2.7 TDI

Engine code: AMB, ASB, BFB, BKN, BKS, BMK, BNG, BUG, BUN
BPP, BSG

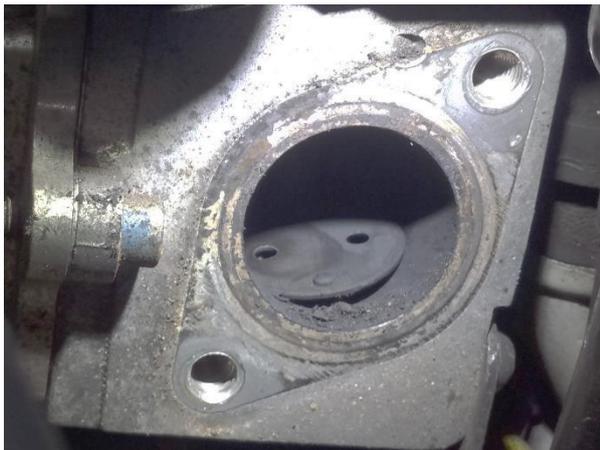
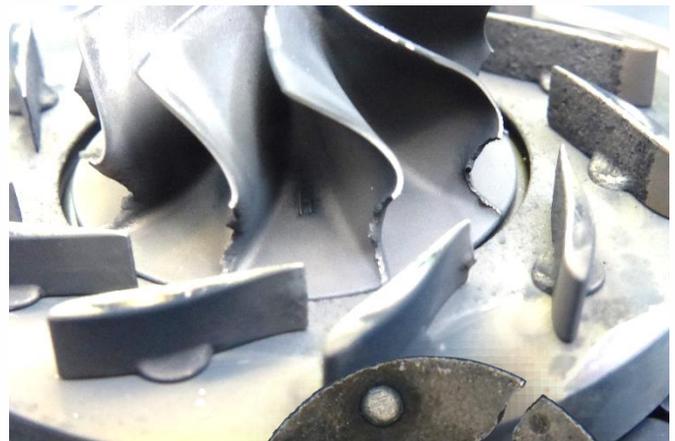
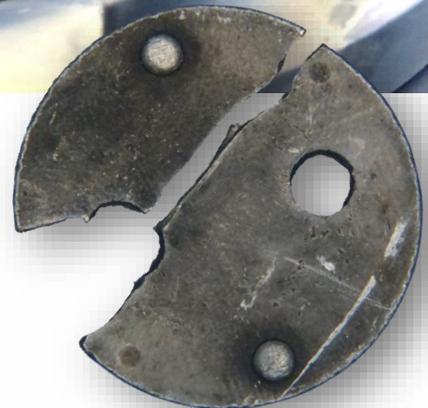
A stiff or jammed VTG unit is often caused by an exhaust-side foreign body damage. The culprit is the broken flap in the EGR valve. The fragments are thrown back into the exhaust manifold during the load change and blown from there into the turbine housing of the turbocharger.

Exhaust manifolds, manifolds and the entire EGR tract should be inspected for foreign bodies and defective parts have to be replaced.
