### Foreign body damage on turbine side caused by broken valve on EGR cooler

**Vehicle:** Traffic II 2.0 dCi, Vivaro 2.0 CDTI

**Engine code:** M9R 780, MR9 782, M9R 786, M9R 788

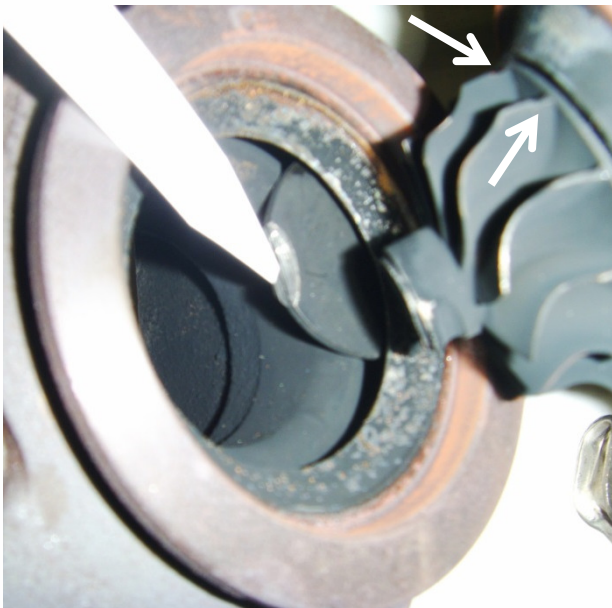
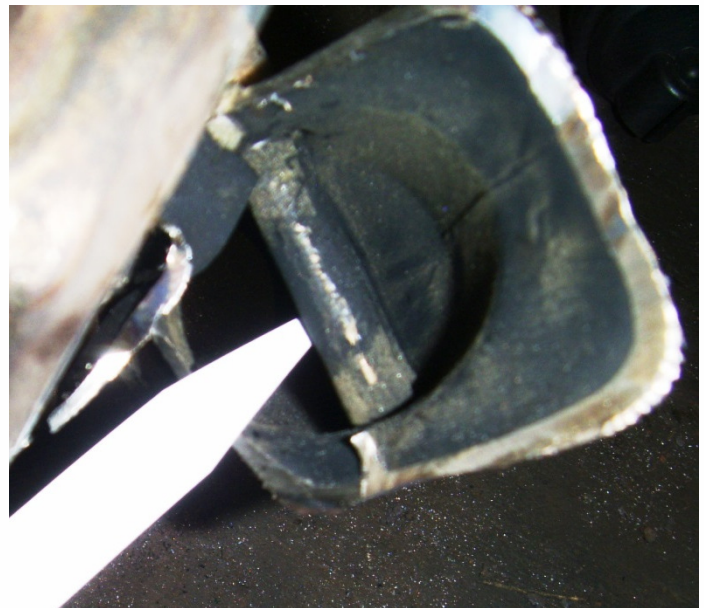
The reason is mainly a broken valve on the EGR cooler. When operating with extreme load changes this fragment is hurled back into the exhaust manifold. The foreign body is then transported through the turbine housing towards the rotating turbine wheel and the inlet edges are damaged. The result is a strong loss of power and sometimes also noises.

If these symptoms or damage occur, please check exhaust manifold, EGR pipes, EGR cooler and EGR valve for any damages or foreign bodies. Damaged components have to be exchanged according to manufacturer guidelines.
