# febi 1000801

To fit: Honda Civic (FK3), CRV (RE6),  
HRV (RU8)

Engine: 1.6i-DTEC

## Manifold Pressure Sensor

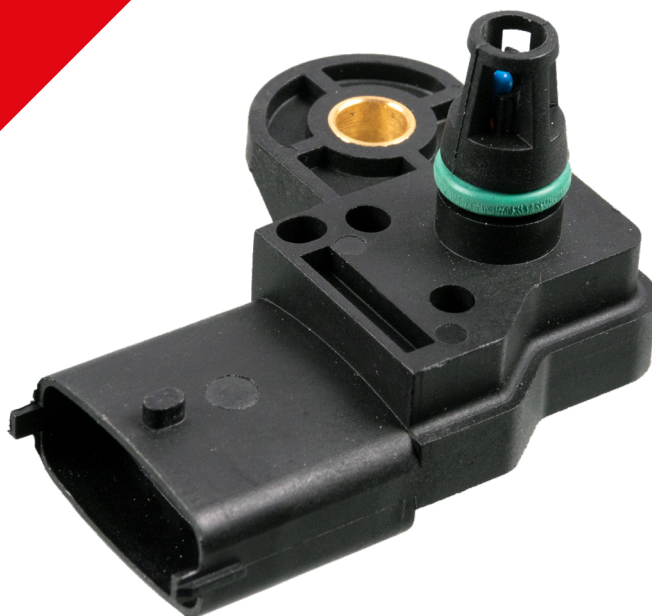
Engine warning lamp illuminated, reduced engine power and the vehicle going into limp home mode.

Moisture in the exhaust gas recirculation system can adversely affect the MAP sensor's temperature-sensing element. This can alter the sensor's voltage, current and resistance characteristics, resulting in an incorrect reading. This then illuminates the engine warning lamp, stores the diagnostic trouble codes and causes the vehicle to go into limp home mode.

Check the data from the sensor with a suitable diagnostic tool, then replace the faulty MAP sensor and clear any fault codes.
