From service department

**Service topic: wiper motors**

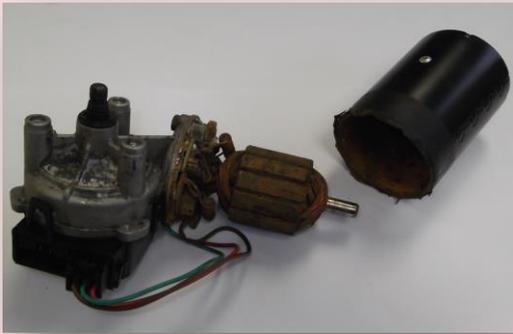
Time and again we receive returns of wiper motors like the one shown in the photo to the left. A quick external glance is enough to already clearly see the rust. The described fault is generally at least sluggish motor performance.

Upon opening such a motor it is not unusual to even discover water within its housing. And although the drive axle is perfectly sound – it is obvious this motor was submerged in water.

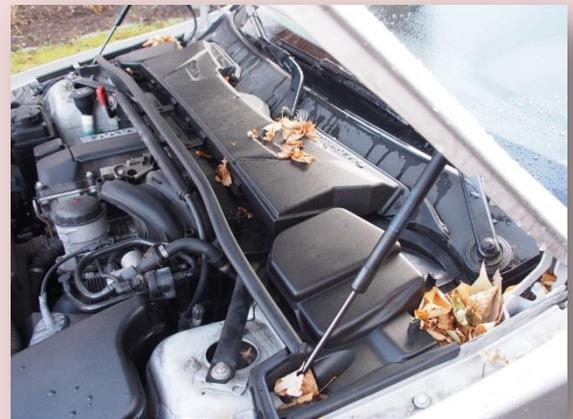
If leaves or other debris clog the drainage holes – as is the case in the vehicle shown – the wiper motor can quickly become submerged in water during heavy downpours.

That is why it is important to ensure the pan is always free of leaves and any other dirt so that water can drain off effectively at all times.
