MINI Cooper S and Cooper JCW (R52, R53)

TVD Pulley for crankshaft

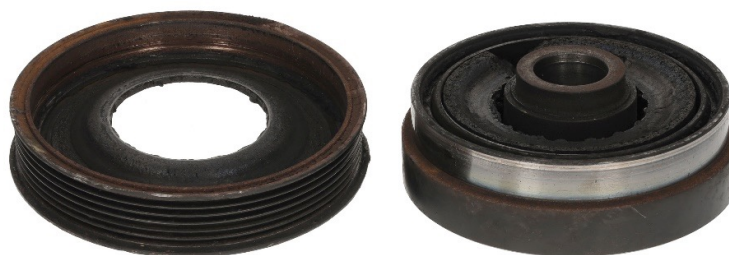
Figure 1

The torsion vibration damper (TVD) crankshaft pulley rubber bonding has deteriorated to the point of failure. This disrupts the auxiliary belt drive to the alternator, air conditioning pump and the supercharger. (Fig.1)

Due to the auxiliary belt not running correctly, the supercharger is not being driven or rotating properly. Therefore, the engine is not receiving the correct air/fuel mixture, logging fault code P1688, which can be misleading in diagnosing this fault.

Check the condition of the auxiliary belt drive system, including the belt, tensioner, all pulleys and the TVD. Replace all damaged and worn parts as necessary and clear any fault codes using a suitable diagnostic tool.
