Audi, Seat, Skoda, Volkswagen
Various models 1.6 & 2.0 TDi engines

Water Pump

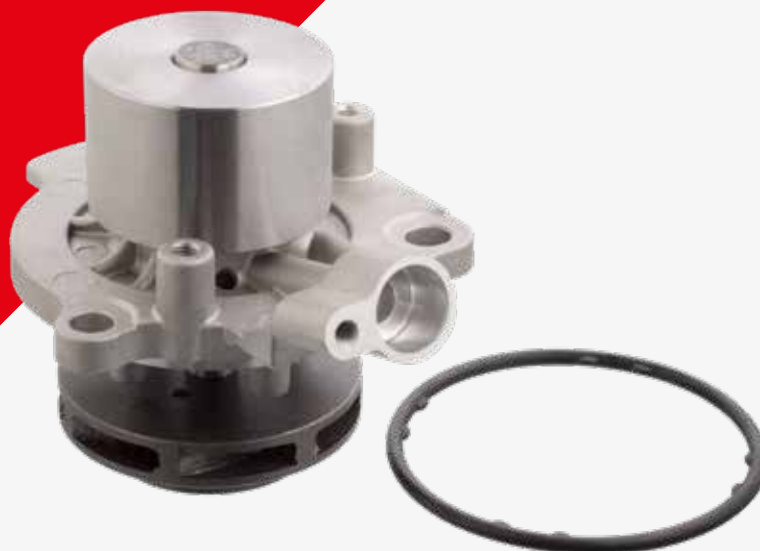
Engine overheating, coolant temperature gauge reading over 110° C and poor interior heater performance. Also cooling system fault codes maybe logged in the engine control unit.

The water pump fitted to these vehicles has an ECU controlled collar, which interrupts the coolant flow to make the engine more thermally efficient. However, the control collar can become seized, or the plastic impeller can break up or come away from the shaft.

Ensure the engine is cool, then remove the coolant filler cap. Remove the small pipe to the coolant header tank and hold this over the filler neck of the header tank, there should be a small trickle of coolant flowing with the engine at idle. This should increase in flow when the engine speed is increased. If the flow rate does not increase, this would suggest a faulty water pump.

Replace the defective water pump with febi 103078, this is a conventional water pump, which eliminates the potential failure caused by the control collar. The solenoid valve must be removed from the old pump and fitted to the new pump. This is so the engine management system can recognise it. Failure to replace the solenoid valve will log an engine management fault.

Fill the cooling system with the correct coolant, then vacuum bleed the cooling system. Finally carry out the cooling system bleeding procedure, using a suitable serial diagnostic tool, to expel all the air from the cooling system.
