Failure of turbocharger, weak performance, loud noises, heavy smoke development, oil leakages, increased bearing clearance

Vehicle Manufacturer: VW

Vehicle: Multivan, Transporter, Touareg

Engine Code: AXD, AXE, BDL, BLK, BPE, BAC

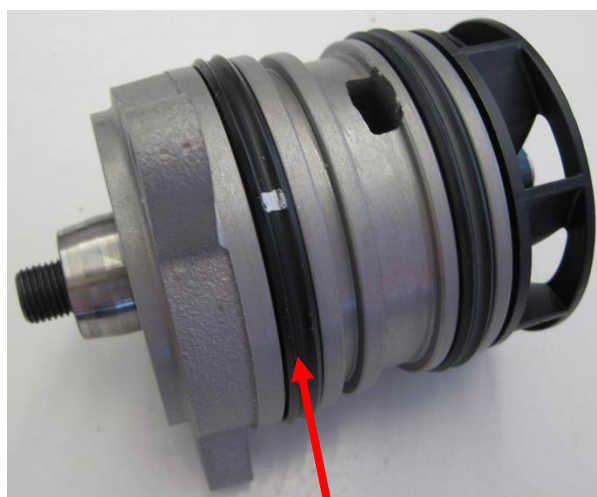
Gasket A

If these vehicles have a damage on the water pump and the drain hole is consequently blocked, cooling water may flow through sealing A (see picture) into the crankcase and lead to thinning of the lubricating oil.

Please note: If there is no oil pressure in the water pump drive, the cooling water may only flow into the oil but not the other way round!

The addition of cooling water in the engine oil will lead to a turbocharger damage due to lack of oil.
