Peugeot 107 Clutch Replacement

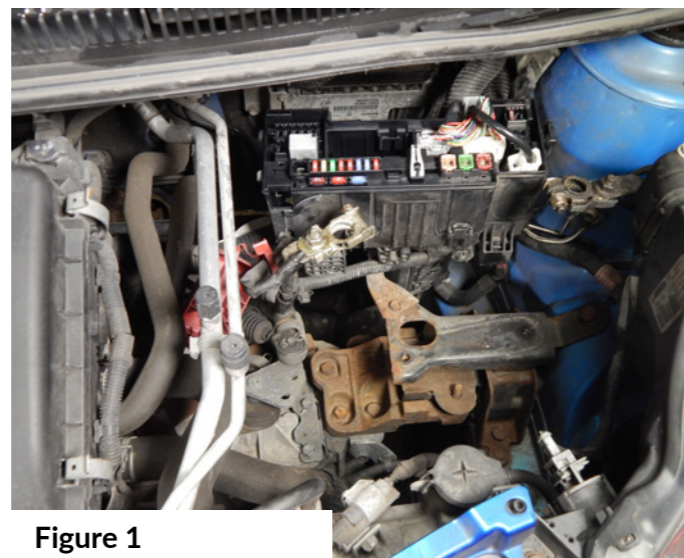
Figure 1

With the vehicle in the workshop, the bonnet was opened and the battery was removed, followed by the battery tray. The tray is held in place by four bolts, however there are also several retaining clips connected to the fuse box which need detaching before it can be removed. Once removed, this revealed the gear selector linkage cables and clutch cable. The "R" clips were removed (which retained the gear linkage cables) and the clutch cable was loosened. This was followed by the unbolting of the retaining bracket from the transmission. The cables were then retained out of the way, until they were required to be refitted. (Fig.1)

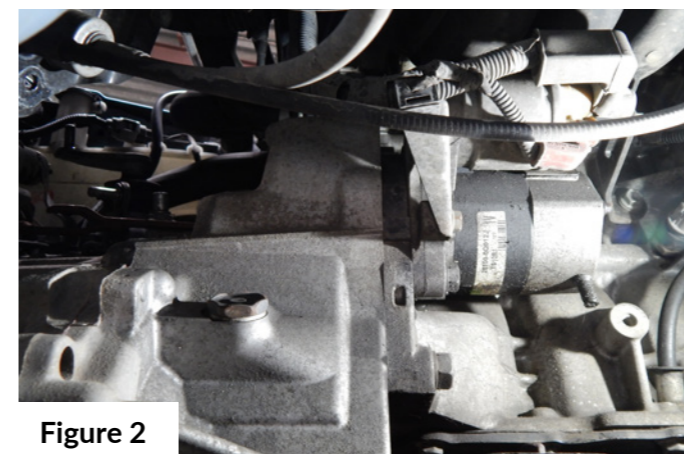
Figure 2

Note: the starter motor was left in place as it does not need to be removed completely for the removal of the transmission. (Fig. 2)

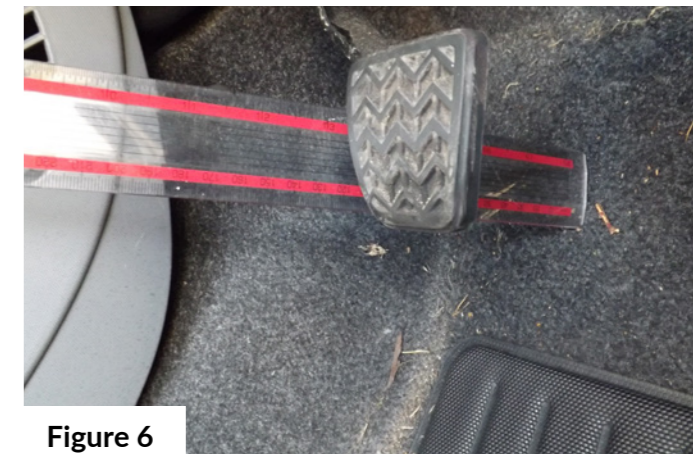
Figure 6

The distance travelled by the pedal was then measured with a ruler. **Note: the amount of free play in the clutch pedal is required to be 23mm, +/- 5mm (Fig.6). This check and adjustment should be carried out at every routine service.**

The clutch cable was revised accordingly, until the tolerance was achieved. With the new clutch fitted and adjusted correctly, the car was road tested for perfect operation.

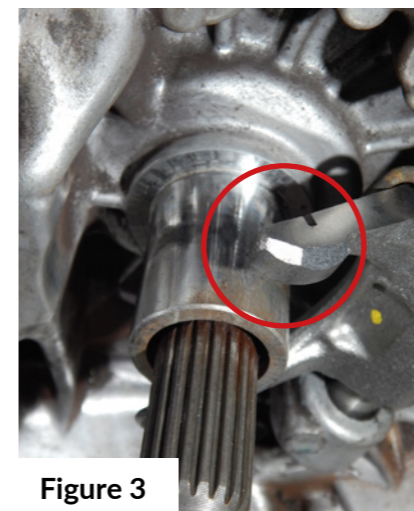
Figure 3

Next, the new release bearing was fitted. **Note: it is important to correctly locate the retaining clips on the fork and the orientation of the release bearing - failure to do so can create operational issues with the clutch mechanism** Fig. 3 highlights the locating groove in the fork. Fig. 4 shows the incorrect orientation of the release bearing, whereas Fig. 5 demonstrates the correct fitment of the bearing with the clip located in the groove.
