### loss of power or boost pressure error, exhaust-side foreign body damage due to defective tumble valves

**Vehicle Manufacturer:** Opel, Vauxhall

**Vehicle:** Astra J, Zafira C, Insigna 2.0 CDTi

**Engine code:** A 20 DTC, A 20 DTJ, A 20 DTH, Y 20 DTJ, Z 20 DTJ

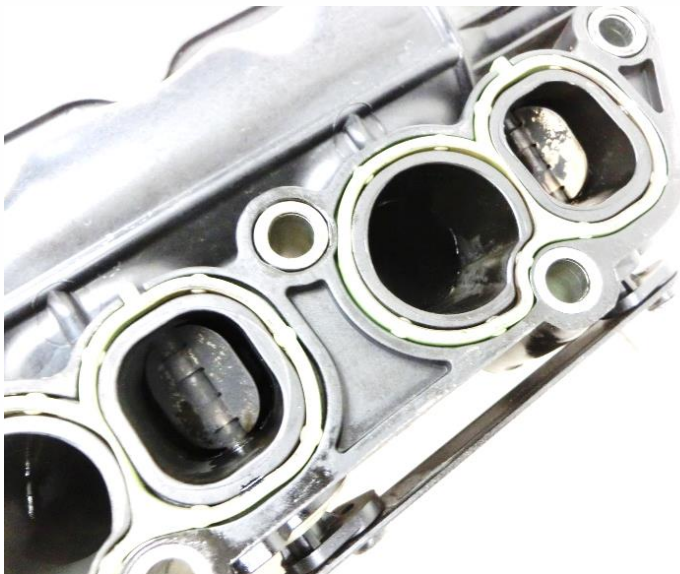
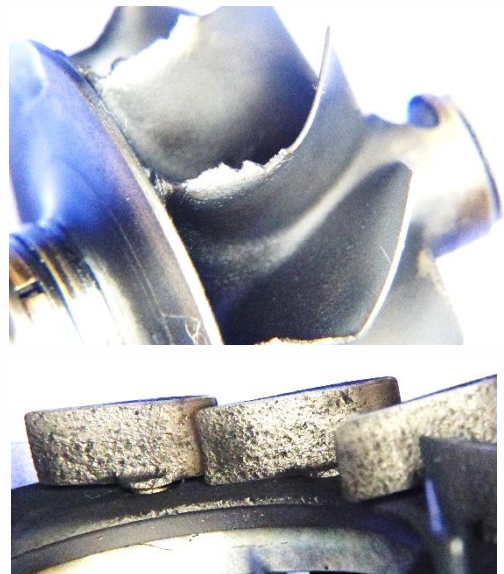
If a stiffness of the VTG unit due to massive dislocation of the internal components due to excessive exhaust gas back pressure is ruled out, then expect an exhaust-side foreign body damage. This is often based on defective tumble valve system in the intake manifold. Break off components are dragged through the combustion chamber and destroy the gas inlet edges of the turbine wheel and mechanical components of the VTG unit.

The intake manifold must be replaced if damaged bearings of the tumble valves or in the absence of tumble valves.

For these engines, we recommend to renew the oil inlet and oil return lines of the turbocharger. It is often noted that there is overheated bearings of the rotor shaft and lack of lubrication damage.
