# febi 188086

To fit: Volkswagen Transporter T6 2.0 TDI

Engine codes: CXEB, CXGA,  
CXGB, CXHA, CXHB, CXEC

## Turbocharger

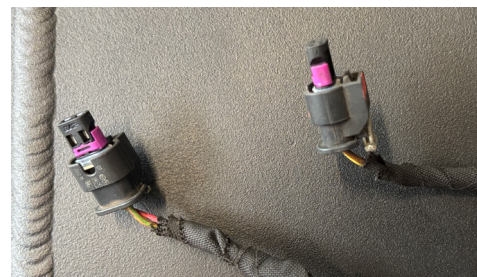
Fig. 1

When removing and refitting the turbocharger, it is possible to mistakenly interchange the connectors for the fuel temperature sensor and the intercooler temperature sensor. Both connectors are a 2-pin design, and both sets of wires come from the same wiring harness and are very similar colours - yellow-orange for the fuel temperature sensor and yellow-light brown for the intercooler temperature sensor. (Fig.1)

Refit the connectors for the fuel temperature and intercooler temperature sensors into their correct positions. Reset any fault codes relating to this issue and road test.

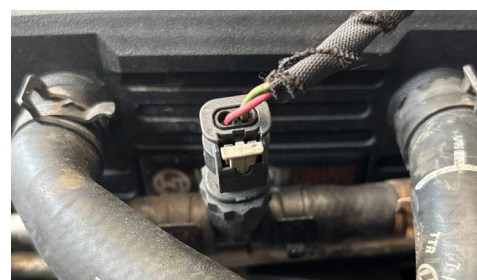
Fig. 2: Fuel temperature sensor

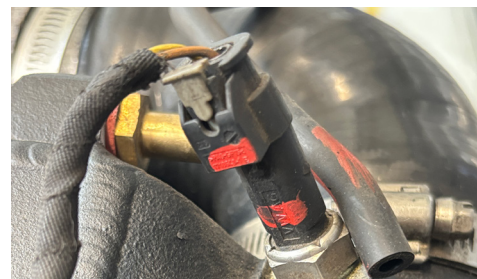
Fig. 3: Intercooler temperature sensor

**Note:** Before dismantling, it is recommend to mark one of the connectors and sensors with a coloured marker, as shown in Figure 3, to prevent them from being mixed up after the repair.
