febi 171970, 172004

To Fit:
various Volkswagen, Audi,
SEAT and Skoda models

Bracket for camshaft

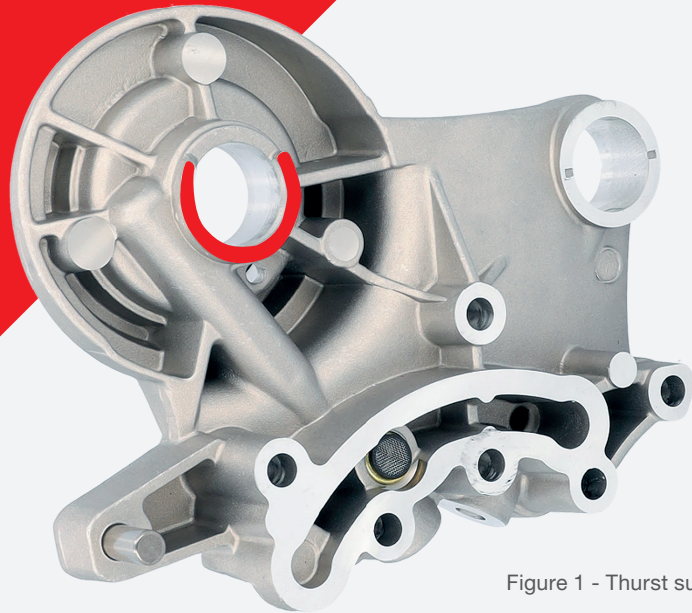
Figure 1 - Thrust surface

However, on some 2016 and 2017 model year vehicles equipped with the 2.0 TFSI engine with engine codes CPMB, CAED or CCTA, fault code P0016 may be set due to a worn intake side and camshaft bearing bridge thrust surface.

- Measure the 'end play' of the intake camshaft.
- If the 'end play' of the intake camshaft is less than 0.2mm, it is within the manufacturer's tolerances. The cause of the fault code could be excessive elongation of the timing chain or failure of the oil non-return valve for the camshaft timing control, which will require further investigation before proceeding.
- If the 'end play' of the intake camshaft is greater than 0.2mm, replace the camshaft bearing bridge with the improved febi part 171970 or 172004 which has a 50% larger thrust surface area than the original. (Fig.1) This matches the OE part 06H 103 144K which was brought into vehicle production in October 2017.
- It is also recommended that the engine oil and filter are replaced as part of this repair.
