Broken rotorshaft due to overspeed**Please note:**

Vehicle Manufacturer: VW, AUDI, SKODA, SEAT

Vehicle: Golf, Jetta, Touran, Passat, A3, Octavia, Toledo, Altea

Engine Code: BKD

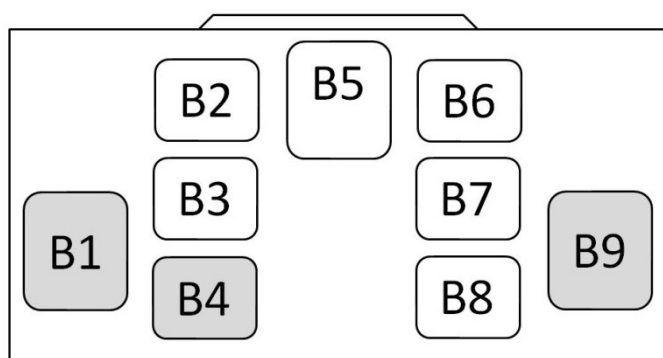
The new turbocharger may fail after a few thousand kilometers after being exchanged, mostly with a broken rotorshaft.

The reason is always a malfunctioning of the load-shedding contact relay X or the power relay clamps 15 or 30 (description R1/R4 or R9).

The OBD does not show any errors. Only a complete scan of the vehicle electrical system may occasionally show errors on the power supply of e.g. ABS, steering assistance or window lifter. In most cases a weak battery is blamed for those errors. But this is not the case here.

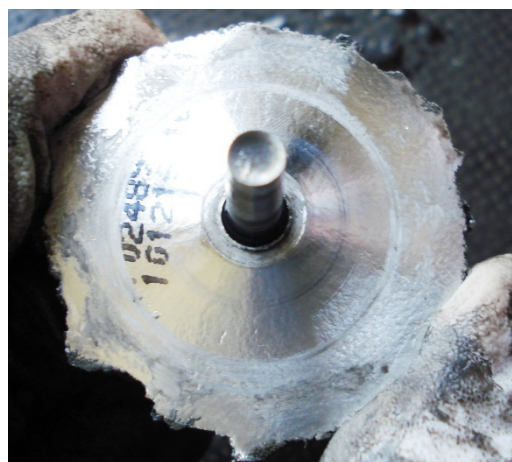
Power relay in the dashboard
Clamps 15 (B1) and 30 (B4) or rejection relay (B9)

Due to the too low vehicle voltage, the sensors are supplied with a wrong voltage and consequently send wrong values back. As a result, the VTG is being closed occasionally under full pressure, leading to the turbine wheel turning in overspeed ranges. This leads to a deformation of the compressor wheel with a consequential imbalance. The applied oil pressure cannot keep the lubrication upright, leading to lack of lubrication and in most cases breaking of the rotorshaft.
