febi 21764

Seat Cordoba,
 Seat Ibiza II, III (1.4 16V AFH, 1.0 16V AVZ)
 VW Polo 3 (1.4 16V AFH)

Timing Belt Tensioner

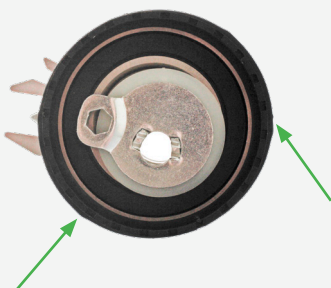
The belt tensioner causes timing belt vibrations which leads to noise.

The original version of the timing belt tensioner (repl. no. 036 109 243 D and 036 109 243 G) is round in shape. The round shape leads to the timing belt vibrations and noise described. This version has been replaced at VW and is no longer in use.

The running surface of the tension roller with diagonal elevations is not a production fault! The tightening torque of the tension roller screw is 20 Nm.

febi recommends using timing belt tensioner febi 21764 (repl. no. 036 109 243 J). This noise-optimised belt tensioner has been developed specially for the applications outlined above. The running surface of the belt tensioner has diagonal elevations (see photos). It is deliberately like this to ensure that the timing belt runs more smoothly. The uneven running surface reduces vibration of the timing belt. At the same time, it also means a longer service life for the timing belt.
