## LuK Service Info

# Features of gearbox installation

## Clutch disc failure

Models: Jumper II, Ducato, Boxer

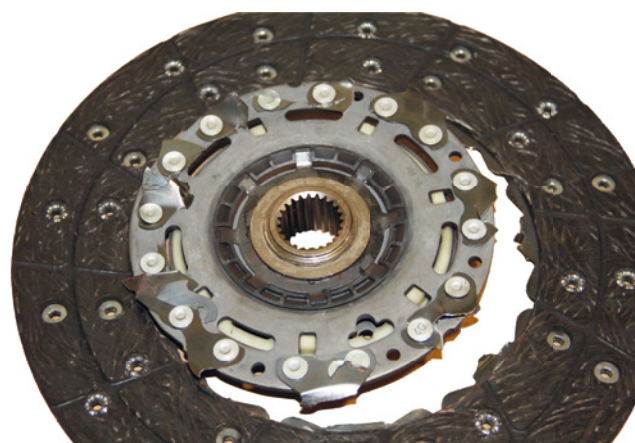
Image 2: Broken clutch disc hub

Errors during car repairs can lead not only to decreased driver comfort and a shortened service life of parts, but in some cases to significant damage to components. One of the common malfunctions of the aforementioned LuK Rep-Set, which are installed on Citroën, Fiat, and Peugeot 2.3 and 3.0 diesel engines, is a broken clutch disc hub (Image 2). The driver experiences gear shifting problems. These symptoms usually appear after a mileage of 2,000 to 20,000 km following a clutch replacement. In these engines, the alignment dowels on the cylinder block, which determine the relative position of the gearbox bell housing to the engine block, are located relatively close together (Image 1).

To prevent the disc hub from being turned off or the ring-shaped leaf spring from being damaged or displaced after replacing a clutch, it is important to follow the special procedure for installing the gearbox onto the engine. Once the gearbox has been fitted and the central actuator has been bled, the next steps involve loosening and retightening the gearbox bell bolts while depressing the clutch pedal. This process is described in more detail in the manufacturer's instructions. In addition, new centering pins must be used and must not be allowed to become deformed or compressed.

The alignment pin grooves should be vertical at the bottom to prevent moisture accumulation. Only installations carried out in this way guarantee parallel and angular alignment of the units, as well as the long-term operation of the replaced parts. Additionally, before replacing the clutch, it is important to pay special attention to the condition of the gearbox input shaft splines.

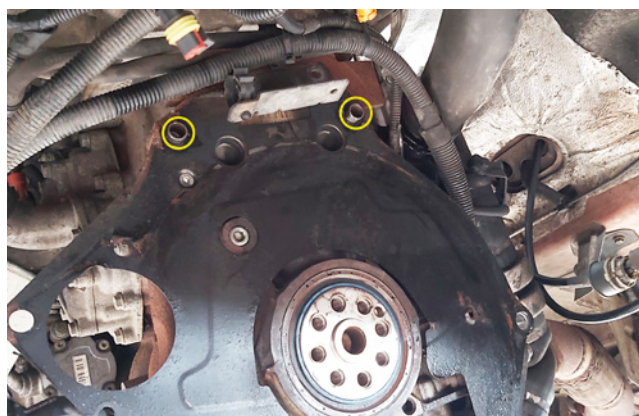
Image 1: The alignment dowels on the cylinder block
