PI 1839
For technical personnel only!
1/2

PRODUCT INFORMATION

REPAIR KIT FOR MERCEDES-BENZ M272 INTAKE MANIFOLD

IS THIS PROVISIONAL SOLUTION ADVISABLE?

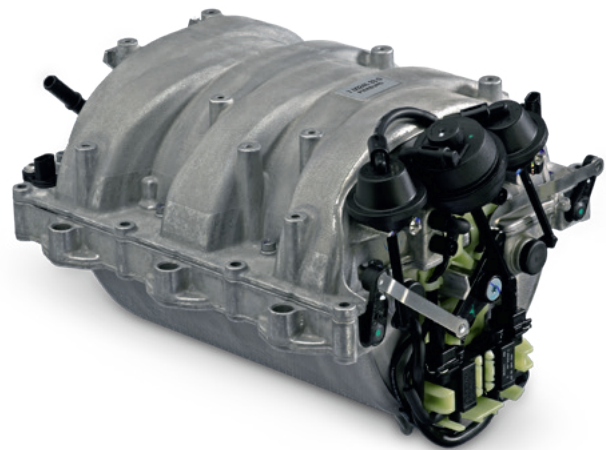
Variable intake manifold 7.00246.33.0

With this variable intake manifold for Mercedes-Benz M272, unfavourable conditions can cause the plastic material of the cam control mechanism to become porous. We are aware of repair kits for the variable intake manifold from various markets.

WE THEREFORE ADVISE AGAINST USING THIS REPAIR KIT.

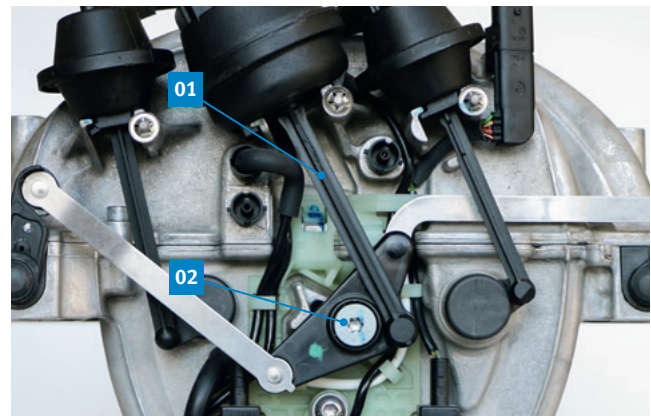
Cam control mechanism

- With this provisional solution, the rod (01) of the pressure box must be trimmed to the exact correct dimension. Otherwise, the damper adjustment is out of alignment and the vehicle loses performance or generates an error message.
- The adhesion between the adapter piece and the rod (01) can become unstuck – with the same consequences.
- The central screw (02) is self-tapping. Once it becomes loose, it no longer holds securely.
- If the actual cause is not removed, the repair solution may also break (see the following page for the causes).
- The installation and removal of the intake manifold takes approximately two man hours depending on the vehicle in question – the provisional solution is not taken into account here. If the fault occurs again, the same time is required a second time – and the costs for you are doubled.
