This new version replaces all previous versions. Please replace SI-110202 / Si110330
lack of power, boost pressure control error and noises,
exhaust gas turbine damage due to exhaust manifold

Vehicle Manufacturer: BMW

Engine code: M57 D25, M57 D30

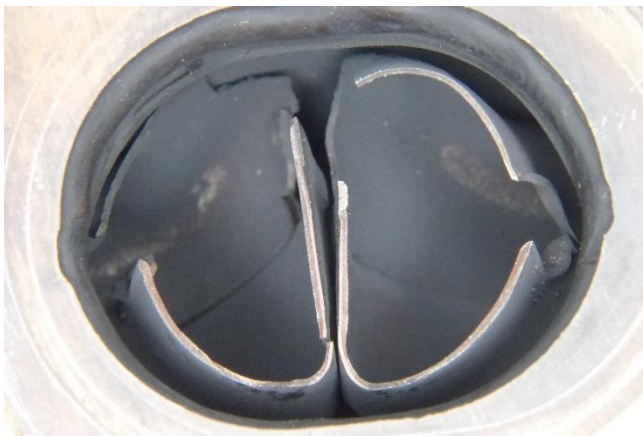
In the vehicles listed below, the vehicle manufacturer has installed an air gap-insulated exhaust manifold in the course of further development. This exhaust manifold (exemplarily 1162 7 798 422) may suffer stress cracks in the interior. It solve small pieces of sheet metal, which are thrown with the exhaust gas in the exhaust gas turbine of the turbocharger. These foreign objects destroy the turbine wheel and damage the wings of the VTG unit. This often ends in a stiff or jammed VTG unit in the turbine housing.

defective exhaust manifold

Check if an air gap insulated sheet metal manifold is installed. If so, then this is to examine for cracks in the inner life. In case of doubt we recommend always to renew the exhaust manifold.

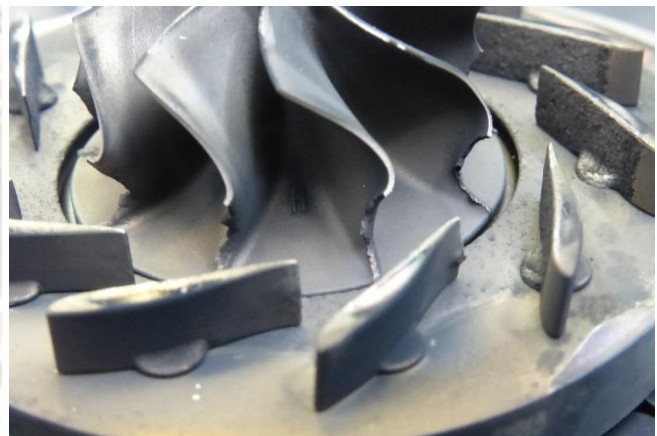
Fault memory entry with boost pressure undershot or even exceeded is the most common vehicle symptom. Is the cause of the turbocharger damage not detected and at the same time eliminated, then a consequential loss is almost unavoidable.

For turbochargers with electric actuator fault memory entries are stored relative to the e-actuator. The actual error is then usually a stiff VTG unit.

destroyed turbine wheel and VTG unit
