**To fit:** BMW 1 Series – E81, E82, E87, E88.  
3 Series – E90, E91, E92.

## ABS Ring

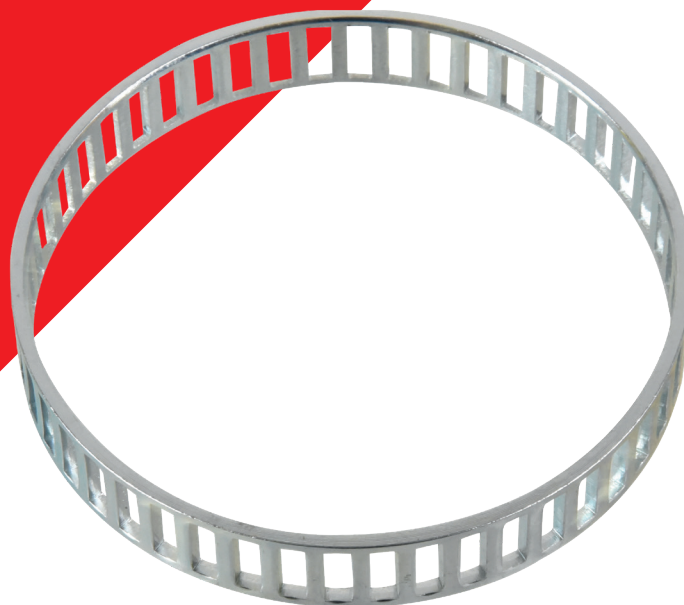
One or more of the following instrument warning lights are illuminated: ABS, traction control or brake light. The vehicle also has intermittent loss of power. Using a suitable diagnostic tool check for fault codes. However, these may be intermittent at the time of testing.

5DC1 = RHR wheel speed sensor plausibility, ABS – DSC wheel speed sensor.  
5DB1 = RHR wheel speed sensor plausibility, ABS – DSC wheel speed sensor.

Corrosion builds up behind the ABS reluctor ring causing distortion or fracturing. As such, the reluctor ring runs out of true and makes contact with the wheel speed sensor. The resulting lack of air gap causes the fault in the braking system and the warning lamp to illuminate.

Raise the vehicle, inspect the driveshaft for corrosion and remove the wheel on the side with the fault. Remove the 12-point (30 mm) hub nut, then undo the six E12 bolts fixing the driveshaft to the axle. Remove the driveshaft from the vehicle. Inspect the driveshaft for excessive corrosion around the ABS reluctor ring. If the driveshaft is badly corroded it should be replaced.

Alternatively, remove the damaged ABS reluctor ring, clean up the mating surface of the driveshaft where the reluctor ring fits, then install the new ABS reluctor ring (febi replacement part 178022).

Remove the ABS sensor and check for wear or damage. Replace as necessary using febi part 32660 for vehicles without active steering, or 102856 for vehicles fitted with active steering. Refit or replace the driveshaft using a new hub nut (01701) and refit the driveshaft bolts making sure that they are tightened to the manufacturer's specified torque setting. Replacement driveshafts for each model are available from febi with the reluctor ring already fitted.
