Hyundai ix35 Clutch Replacement

This popular Hyundai model range was introduced in 2004 and is a high-seller worldwide as demand increases for sport-utility crossover vehicles. The model featured in this article is a second-generation ix35 - also known as the "Tucson" in some markets between 2009 and 2015. This example is front-wheel drive, equipped with the 1.7-litre diesel engine and a six-speed transmission. An intermittent clutch 'squawking' noise in slow-moving traffic had been reported; this required investigation.

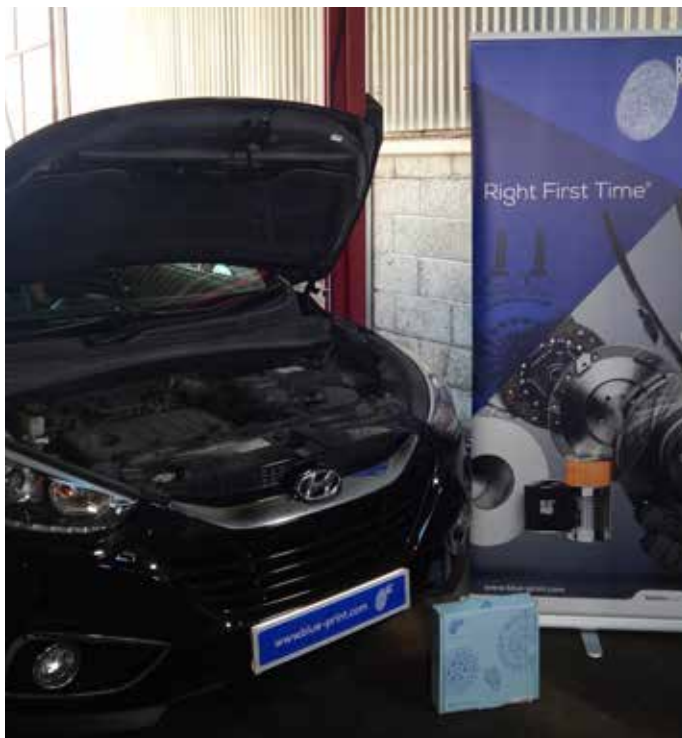
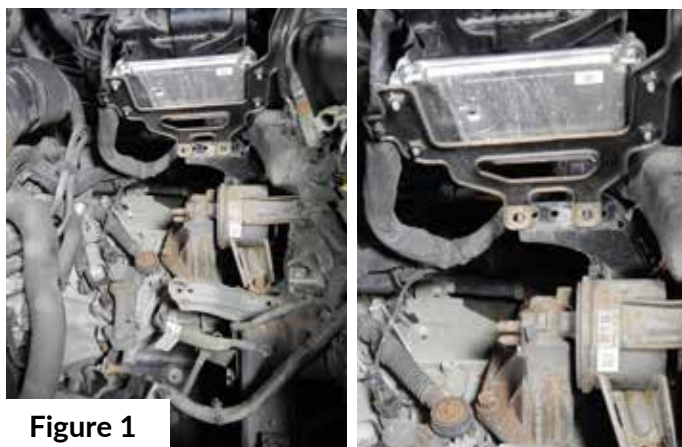
Figure 1

The plastic engine cover was removed, followed by the air cleaner assembly, air duct and upper intercooler hose. Next was the removal of the battery and battery tray, leaving the engine control unit connected to the wiring harness. With the top of the transmission exposed, the reverse lamp switch and neutral switch were disconnected and the earth cable unbolted. (Fig.1)

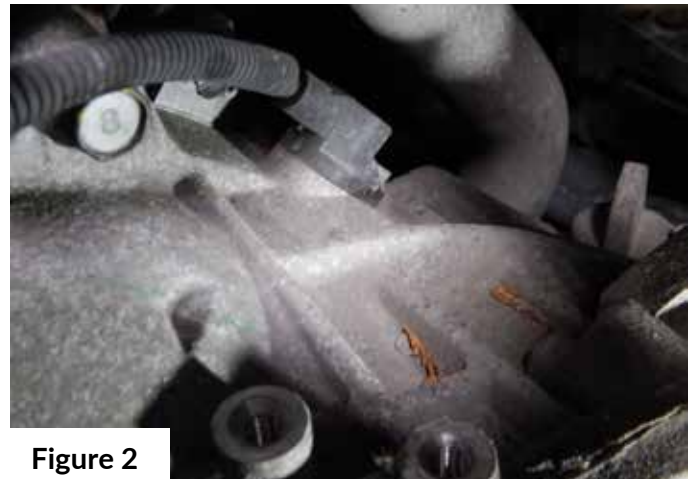
Figure 2

The three bracket bolts were removed along with the bracket, so as to gain access to the two top transmission-housing bolts. This was followed by the removal of the crankshaft position sensor, including unclipping it from the wiring harness. If the sensor was not removed, it would be damaged against the flywheel upon removal of the transmission. (Fig.2)

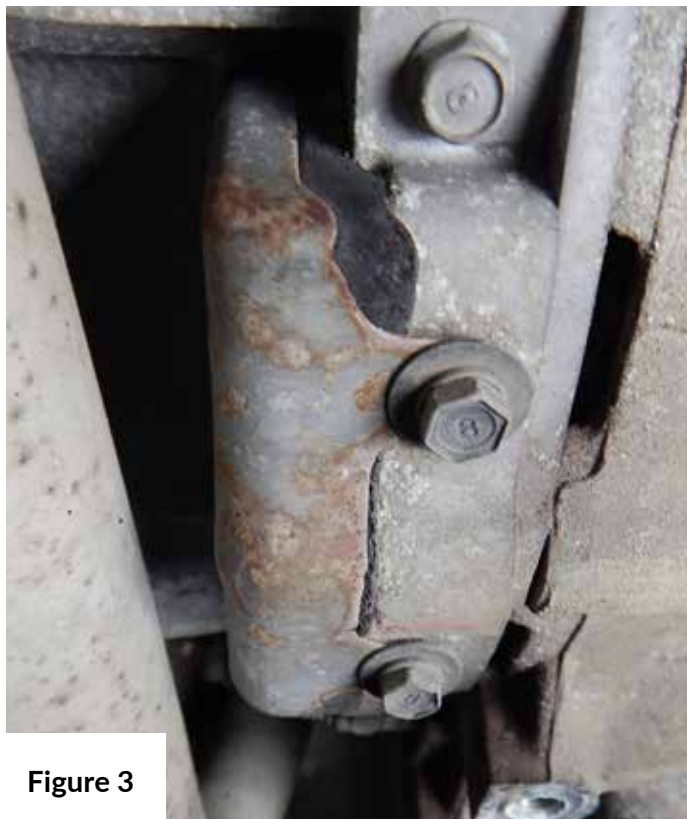
Figure 3

The lower transmission mounting was taken off - including the retaining bracket attached to the base of the transmission - along with the dust cover, to reveal any hidden bell housing bolts. (Fig. 3)

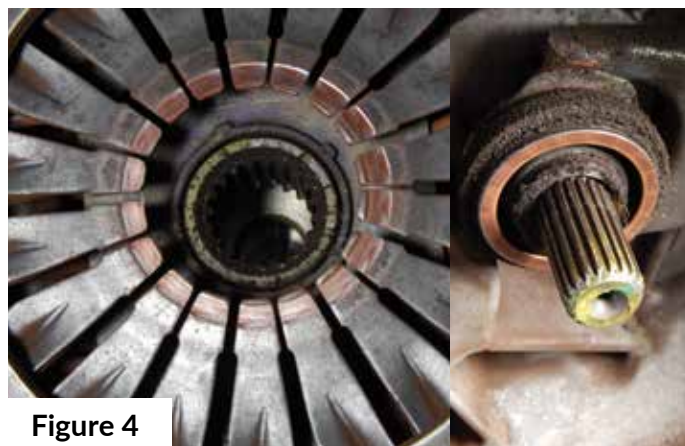
Figure 4

With the transmission removed, the clutch pressure plate and friction disc were removed from the flywheel and inspected for any unusual wear issues in order to diagnose the possible cause of the clutch's 'squawk' noise.

The release bearing was found to be worn and noisy, along with a worn pressure plate diaphragm spring. (Fig. 4)

required cleaning before fitting a new clutch kit. Blue Print clutch kit ADG030203 was chosen as the replacement, along with clutch slave cylinder ADG03644.

The bell housing was cleaned and inspected, followed by the replacement of the release bearing. A small amount of grease was applied to the input shaft and then the transmission was ready to be refitted to the engine.
