**febi 36626****38444, 38450, 38851**

FWD Ford Transit, Tourneo

Engine 2.2-litre TDCI Duratorq

Crankshaft Pulley

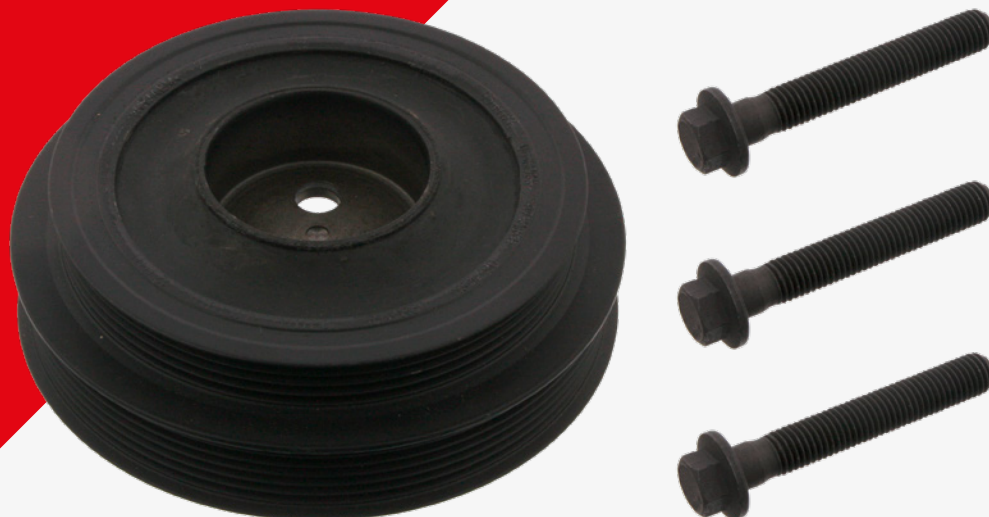
Typical problems include: Abnormal noise and vibration from the timing belt area; Alternator warning lamp illuminated; Power steering belt damaged or has come off the pulley.

Over time, water and road debris ingress into the torsional vibration damper crankshaft pulley, causing premature wear and the failure of the crankshaft pulley and auxiliary drive belt system.

Replace the crankshaft pulley with febi Prokit 36626 which includes all of the necessary bolts. All damaged or worn auxiliary drive belts should also be replaced.
