Sudden noises with poor performance, foreign object damage on the compressor side

BTS reference: T915419 **BTS-Service-Set-Nr:**

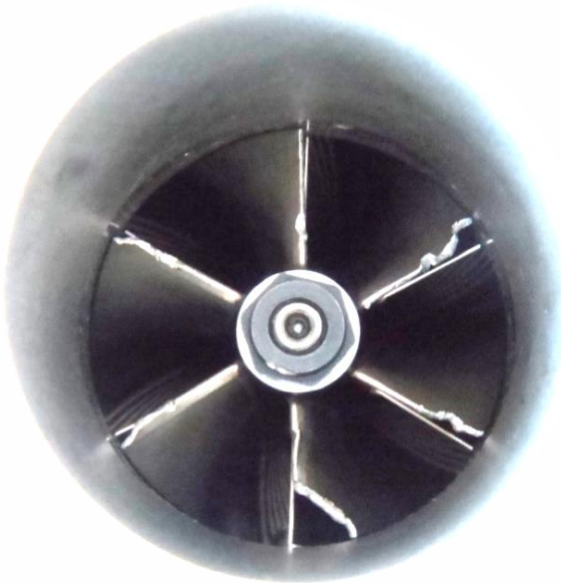
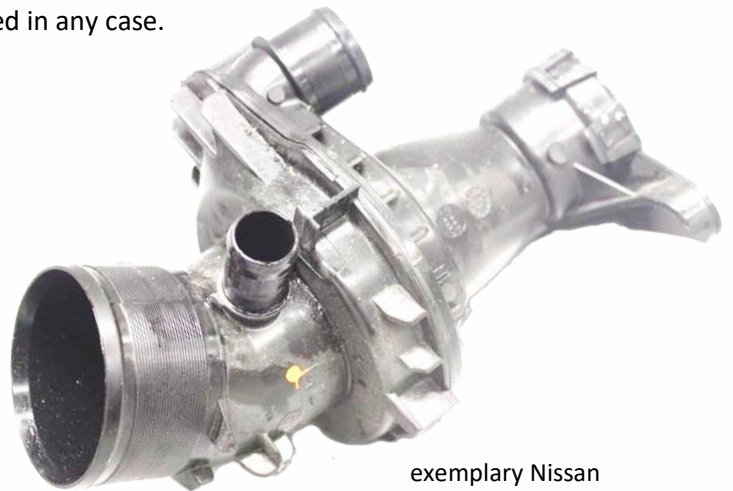
exemplary Nissan
„air intake pipe“ complete
1657600QE

After installing a new turbocharger, noises with an associated lack of power occur after a short running time. The visual inspection of the compressor wheel shows damage to the air inlet edges. Breakouts on individual wings are not uncommon.

These vehicles are also equipped with a low-pressure EGR. After the diesel particulate filter, exhaust gases are fed into the turbocharger's intake tract via an "air intake pipe". Loosened fragments from the DPF or broken elements from the "air intake pipe" fly into the compressor wheel of the turbocharger. These foreign bodies hit the air inlet edges of the compressor, are repeatedly thrown back and sucked in.

The diesel particle filter and the "air intake pipe" assembly must be checked for damage. The air filter box, airflow meter, intake throttle and the pipings of the fresh air lines up to the compressor must be carefully examined for foreign objects and mechanical damage. The elements of the crankcase ventilation must also be checked for damage.

Defective or embrittled components must be replaced in any case.
