# febi 183819

To fit: Mercedes-Benz A-Class (169),  
B-Class (245)

## Driveshaft

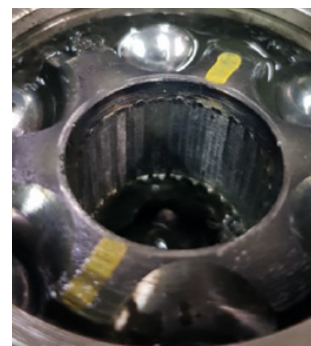
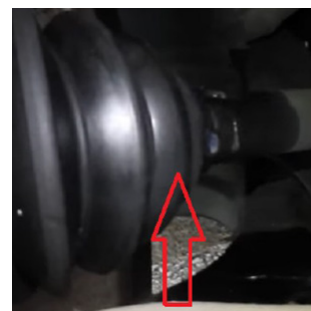
However, this fault may be due to a mechanical issue: a broken right driveshaft. The splines within the outer constant velocity joint have worn, resulting in it being unable to transfer motion to the wheels - the driveshaft rotates but the bearing does not.

Raise the vehicle and check if the driveshaft rotates by hand and drives the wheel. If not, remove the protective rubber boot from the outer CV joint and confirm the diagnosis. Replace the worn driveshaft, check the service history of the transmission and replace the oil and filter if required. Reset any fault codes using a suitable diagnostic tool and road test.
