# febi 39304

various Citroen, DS, Fiat, Ford, Jaguar, Lancia, Land Rover, Mitsubishi, Opel, Peugeot, Toyota and Vauxhall models

## Water pump with gasket

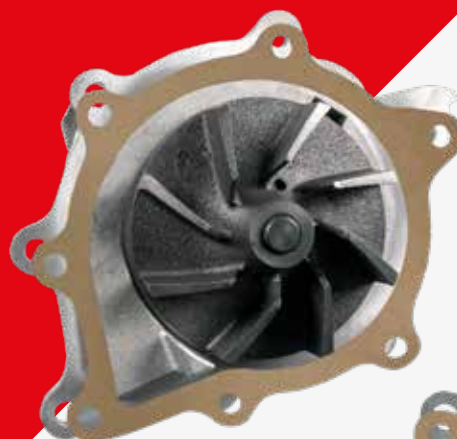
*Improved febi water pump*

Remove the auxiliary belt and timing belt. Replace the defective water pump with febi water pump 39304 (Fig.1), which has an improved water pump design with a metal impeller. This eliminates the potential failure caused by the water pump fitted with a plastic impeller. When replacing the faulty water pump, febi recommends that the timing belt kit and auxiliary drive belt is also replaced at the same time to ensure the reliability of the engine.

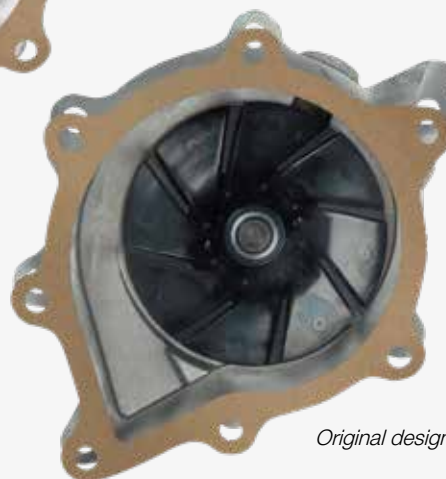
*Original design*

The original water pump impeller is made from plastic, which can become detached from the impeller shaft. Therefore, the water pump is turning with no effect and no coolant will flow around the cooling circuit of the engine.
