# SI-240527

## **Service-Information Turbocharger**

### Intake-side foreign body damage to compressor wheel

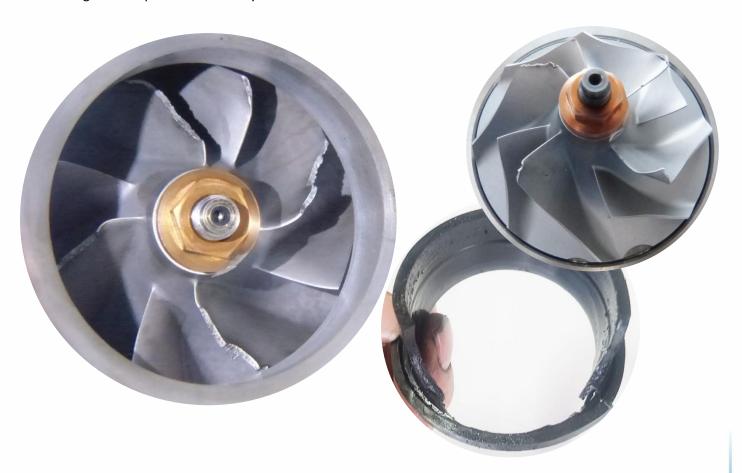
We have noticed that there are noticeably frequent premature failures of the turbocharger with a damaged compressor wheel. Softened or damaged seals on the intake port of the compressor housing cause damage to the compressor wheel, which leads to noise and loss of turbocharger performance.

Large soft foreign objects cause breakouts at the compressor wheel blades in these vehicle types. Individual blades of the compressor wheel are bent up so strongly that the blade-edges go breaking. The broken bits can then lead to impact marks in the compressor housing and on intact blades of the compressor wheel.

Components and seals from the air filter box to the compressor inlet of the turbocharger have to be checked for damages and replaced if necessary. Elements of the crankcase ventilation should also be checked.
