УЕНМАК

Liner | Piston | Ring | Engine Bearing

Service Manual

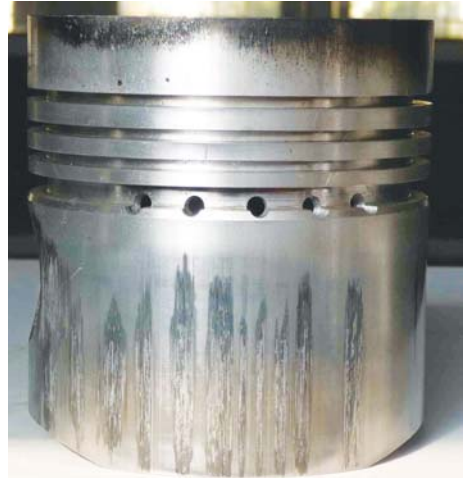
Figure 1

1.1.1 Seizure on the Piston Skirt Description of the Failure

Such failures usually occur in a short time following the engine overhauling operation.

There are two causes for the piston to fail in a manner similar to the image in figure 1. These are;

The space between the Piston and the Liner is reduced due to a failure and problem in the cooling system of the engine. Since the aluminum piston expands 2 times more than the iron cast, seizure failure shall occur in excessive forces and heats.

2-Seizure due to lack of space resulting from Manufacture and Assembly defect

The engine cover is assembled defectively. The bolts of the engine cover are tightened more than the torque values recommended by the engine's manufacturer and the shape of the engine block is changed. In such failures, seizure occurs in the piston in the first housing of the engine.

Recommendations

- Fan belt should be checked. (Worn, defective belt should be replaced.) Tension of the fan belt should be in a manner to stretch for 1-1,5 cm. If it is more loose, the engine overheats.

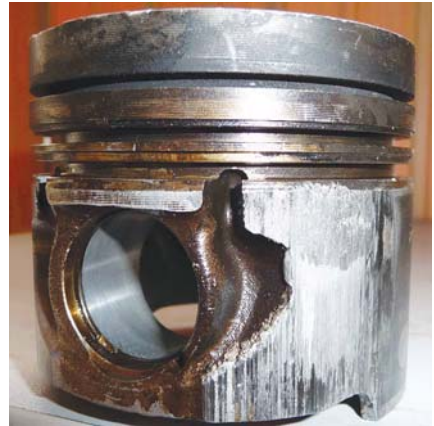
Figure 1

- In such a failure, as seen in Figure 1, the pistons are subject to seizure at 45° of the piston in areas closer to the piston pin bore at the piston skirt.
- There is usually no mark of seizure on contact surfaces of the piston skirt, marks of normal operation are seen on these surfaces.
- The piston pin is not free, it is compressed in the removed connecting rods.
- Marks of seizure can be seen when the piston pin bores are examined.

- As the piston pin and the oil film around it is deteriorated and torn, these areas get overheated, unlubricated, dry operation occurs and causes marks of seizure. The causes of unlubricated operation at these areas and heating as a result of tear oil film are;
- 1 - Connecting rod is assembled defectively in pistons with shrink-fit connecting rods. After the shrink-fit connecting rod is assembled, moving the connecting rod before it is cooled down causes initial seizure and marks of seizure in the pin bore, expansion of unlubricated operation in this area and more important engine failures .
 - 2 - If the piston pin bores and the piston are not lubricated adequately during the engine overhauling operation, marks of seizure due to unlubricated dry operation occur during the initial operation fo the vehicle and the marks of seizure in this area proceed and result in engine failure.

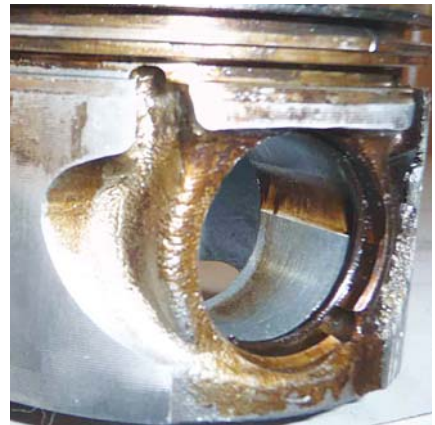
Figure 2

3 - Lubrication of the pistons and the cylinder inside the engine is performed by the oil splashed as a result of the connecting rods hitting the oil inside the engine's crankcase. Operating the engine at idle for a long time to heat it up causes decrease in the engine lubrication and dry operation of the piston in the pin bore, accordingly seizure failures inside and around the pin bore.

4 - A sudden loading on a recently-started engine, applying too much force right after starting causes expansion of the piston upon faster heating than the engine liner and as a result, seizure failure around the piston pin bore.

6- Oil pump should be checked. Faulty oil pump should be replaced.

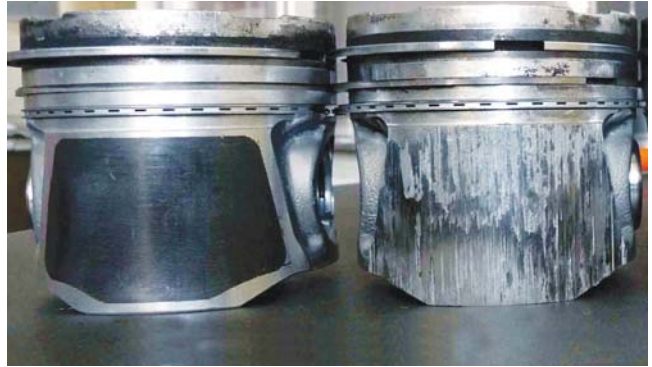
Image 1

- Whereas there are marks of seizure on one side of the piston contact surfaces, there are marks of normal operation on the counter pressure direction. (Figure 1)
- There is no mark of seizure in piston ring areas. Marks of operation at the piston crown are normal.
- There are marks of burnt on the piston rings, although they are not evident.

Surface 1 Surface 2
Piston skirt seizure on only one side

The oil film on one side of the piston is lost and seizure occurs. This seizure especially occurs on the pressure dimension of the piston first. The reason is that the force applied on the pressure direction is higher than the counter pressure direction. The causes of corruption in the oil film on the pressure direction of the piston and unlubricated dry operation are as follows;

- 1 - Leakage of coolant water in the cooling system of the engine and emergence of air bubbles or inadequate level of coolant water circulation inside the engine block due to lime, dirt etc. causes local increase in heat, elimination of oil film, unlubricated dry operation and accordingly, seizure.

- 2 - Low oil level inside the engine and a short-term blockage in the bore of the oil-cooling spray, faulty assembly or failure of it results in engine failure.

- 3 - Faulty assembly of the shroud ensuring direction of the air onto the engine in air-cooled engines causes increase in engine heat and overheating of the engine.

- 4 - The oil used in the engine is not of a nature and quality to bear the engine loads. Dilution of the engine oil causes elimination of the oil film on the engine parts. Unlubricated dry operation occurs between the piston and the cylinder surfaces and piston seizure failure occurs.

- 1 - During the engine overhauling operation, the cooling system should be checked, the cooling channels of the block should be cleaned and the parts to cause leakage of the coolant water should be replaced.

- 2 - Oils recommended by the engine's manufacturer should be used inside the engine.
- 3 - It should be checked whether the oil bores in the connecting rod should be open and operating.

- 4 - The oil level inside the engine should continuously be checked and oil should be added whenever required.
- 5 - The oil pressure should be checked. The causes of low oil pressure are worn oil pump, high amount of dirt inside the oil filter, faulty high pressure valve and corrupted viscosity of the oil. These parts should be checked and replaced.

- 6 - Engine oil should be replaced without any delay in accordance with the oil replacement intervals.
- 7 - Fuel and ignition system should be checked for fuel spillage, which might cause dilution in the engine oil.

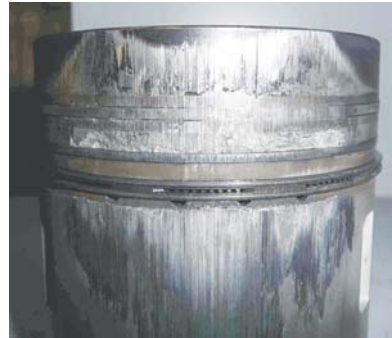
Figure 1

- The marks of wearing and seizure on the piston are mainly on the top of the piston top ring and at the piston rings lands. It is observed in failures, where the marks of seizure at the piston skirt have proceeded, the marks of seizure at the skirt are usually small. (Figure 1)

There is a problem in the injection fuel spray. The fuel is not sprayed from the injection nozzle equally into the fuel combustion chamber. Therefore, the fuel reduces the oil film on the cylinder surface. Unlubricated dry operation occurs at the piston crown upon reduction of the oil film. Overheating and unlubricated dry operation at the piston top ring land causes seizures at this area. Causes of this failure are;

- 1- Leaking injection nozzle;
- 2- Stuck nozzle needle due to damaged or worn injection nozzle;
- 3 - Faulty injection time;
- 4- Faulty injection system
- 5- Utilization of poor quality fuel. (Fuel with inappropriate sulfur value and mixture of faulty additives with the fuel causes failure in injection nozzles and ignition system.)

- 1 - The injection nozzles should be checked during the engine overhauling operation. The injection nozzles should be kept under 20 bars of pressure for 10 to 15 seconds with a clean cloth on them. At the end of this period, the cloth surface should be slightly wet.
- 2 - The injection nozzles, which are determined to be damaged, should be replaced.
- 3 - The injection bolts should be tightened to the torque value recommended by the engine's manufacturer.
- 4 - The injection and the ignition systems should be checked.
- 5 - It should be checked whether the injection timing is correct or not.

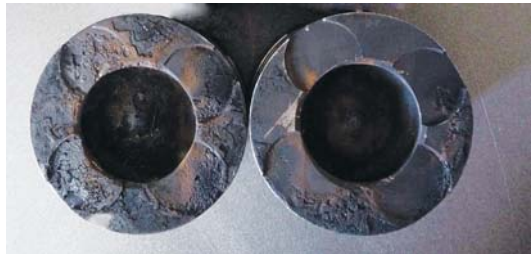
Figure 2

- There is too much soot accumulation on the piston head. (Figure 2)

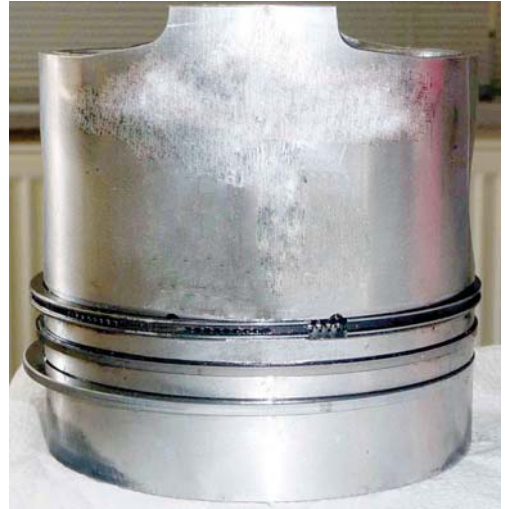
Figure 1

These marks that occur at the piston skirt occur due to lack of space in this area. The causes of this lack of space are as follows;

- 1 - You should be careful about choosing the O-Ring and use an O-Ring of correct thickness.
- 2 - You should apply some grease onto the O-Ring seals during assembly and avoid torsion and distortion.
- 3 - In order to avoid lack of space, you should first assemble the wet cylinder liners without seal. In this way, any lack of space can be determined in advance. After that, the cylinder liner can be assembled completely with the seals.
- 4 -After the honing, you should measure the cylinder bores at several levels and directions.

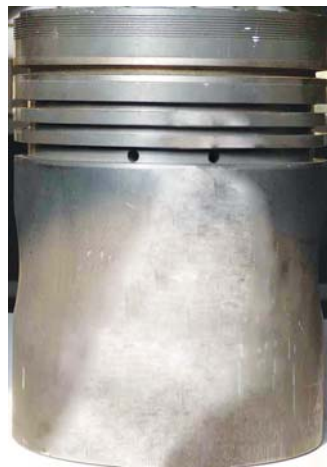
Figure 1

1.1.6 Asymmetrical Wear Pattern on the Piston Skirt

- The piston rod is bended or buckled.
- Bushing groove of the piston rod is turned on an inclined axis.
- Inaccurate assembly order and inaccurate tightening values are applied.
- Space of the rod groove in the piston rod is more than necessary.
- There is dirt on the air-cooled cylinder base. Therefore, the cylinder is inclined on the engine block. Therefore, the pistons operate in inclined position inside the cylinder.

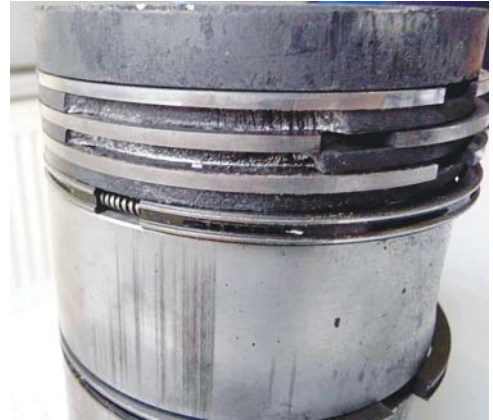
Figure 1

This fracture starts from the top inner edge of the land and advances towards inside of the piston material. While advancing towards the bottom edge of the broken piston ring land, it changes its direction towards outside and goes out right through the bottom edge of the bottom of the piston ring land. Bottom part of the broken piston ring lands is longer than the top part.

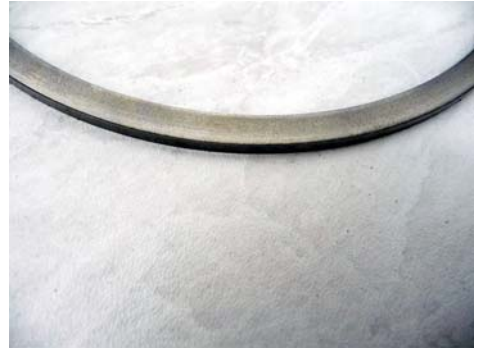
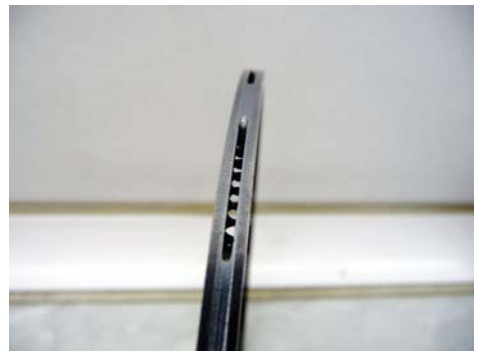
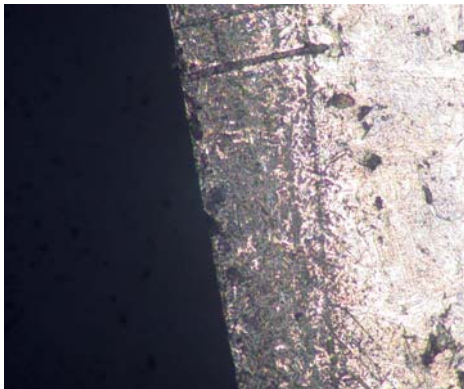
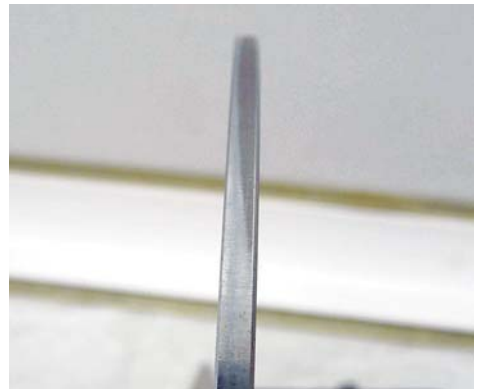
A matte wearing is observed that contact point of the piston skirt with the liner surface. Moreover, piston ring channels wear away and the channel width expands.

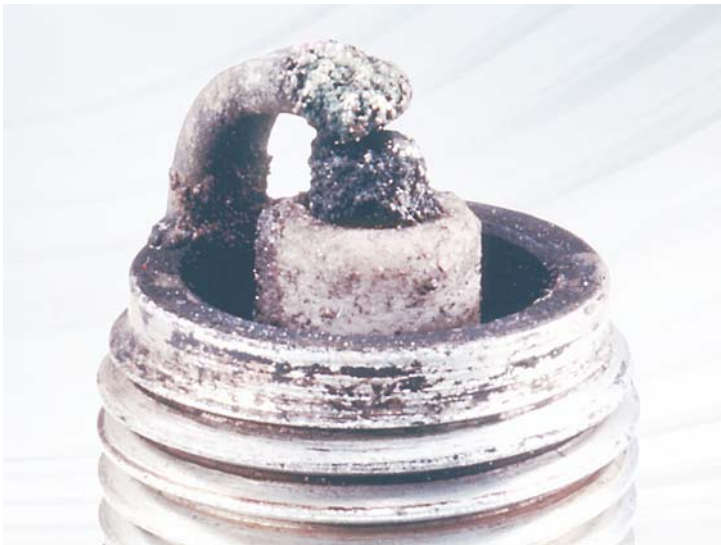
Image of failure spark plug

- Entrance of the lubricating oil into the combustion chamber due to worn rings and valve guides causes the failure.
- Presence of diesel fuel in the petrol used for the vehicle causes the failure.
- Excessive heat inside the engine, in general, causes the failure. The cooling system and the ignition system causing the engine to operate at high temperatures can cause the failure.
- Low temperature of the spark plug causes ignition inside the engine out of the ignition timing for the engine.

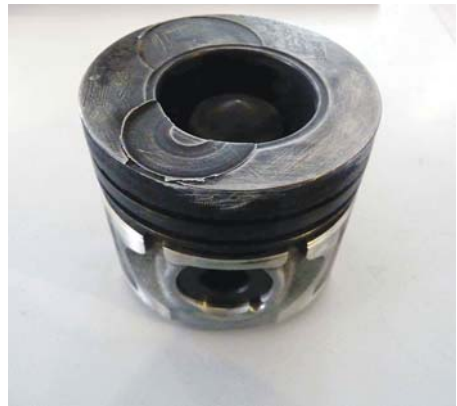
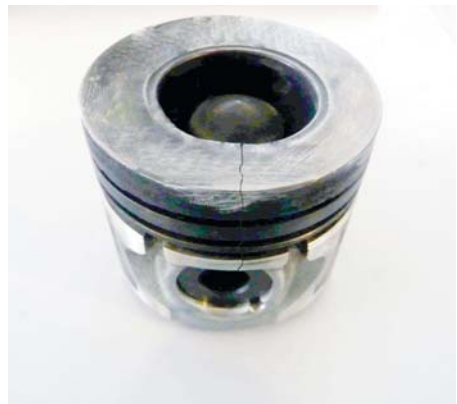
- Inaccurate valve timing adjustment may cause skips in the timing chain or corruption in the timing belt and as a result, the valve knocking occurs.
- The valve springs cannot take the valve back on time due to excessively high speed and accordingly, the piston crashes into a valve or valves.
- Due to the space occurring as a result of the excessively worn piston rod bearings, the valves knock the piston crown.
- After the engine cover honing operation, if the valves do not fit the groove and if there is a protrusion, the valve knocking failure occurs.
- The valve is disconnected.

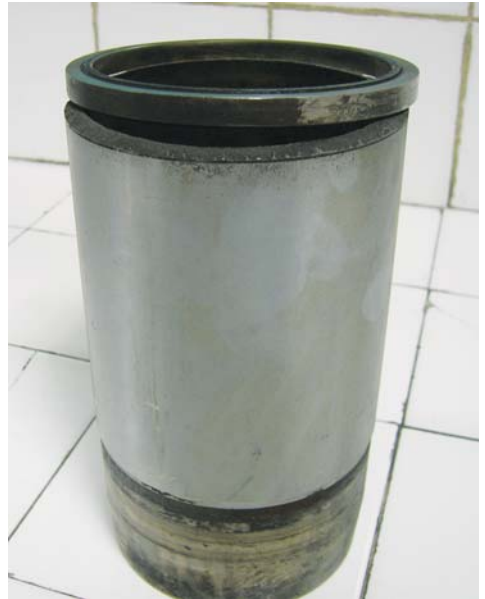
Figure 1

If the height between the surface where the gasket contacts and the cylinder liner flange in the engine block is not appropriate, vibration occurs in the liner with the piston movement due to this gap. The liner flange is snapped off due to the impact of the force caused by the vibration.

1. During rectification of the engine, while processing the cylinder block, adequate number of steel shims should be placed under the cylinder liner flange.
2. Or liners with flanges longer than standard values should be assembled.
3. The height difference between the block and the top point of the flange should be checked after the liner assembly.

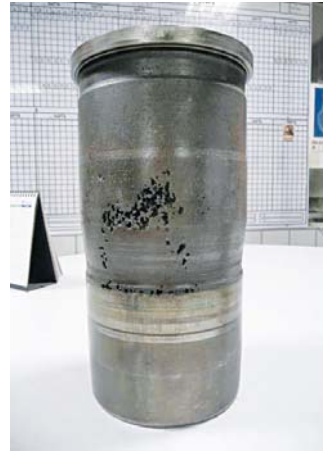
Figure 1

If the cylinder liner does not properly fit the cylinder block or if it is loose for the cylinder piston dimensions, the explosion at the ignition causes vibrations in the cylinder liner. These vibrations affect the flow of the coolant fluid. In this way, the cooling film on the outer surface of the liner is eliminated at certain areas. Steam bubbles occur on the surfaces, where the cooling film is eliminated, due to low pressure and high temperature. The steam bubbles start to hit the surface, where the film is not present in the liner. Due to the force applied by these bubbles, pieces snap off from the surface, holes and even pittings occur.
