INSTALLATIONADVICE

HYDRAULIC LIFTERS

General replacement advice

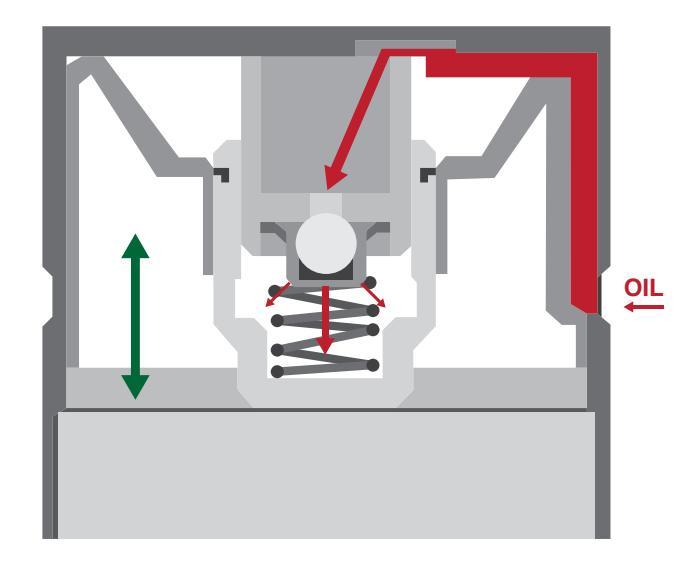
FIGURE 1:

Oil flow and operation of the bucket style Hydraulic Lifter.

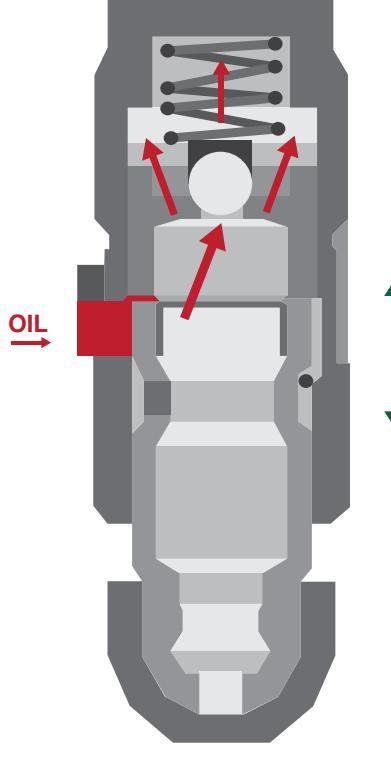
FIGURE 2:

Oil flow and operation of the cylindrical or "bullet" style Hydraulic Lifter.
