Valve Stem and Valve Guide Failures

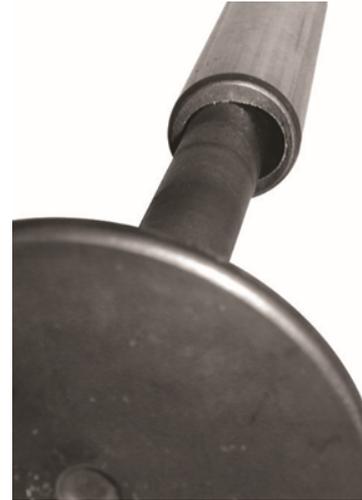
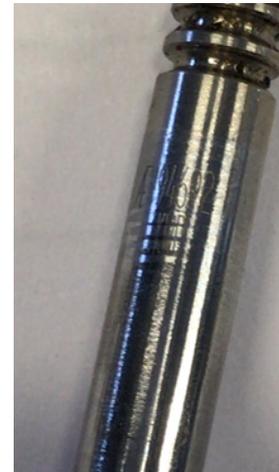
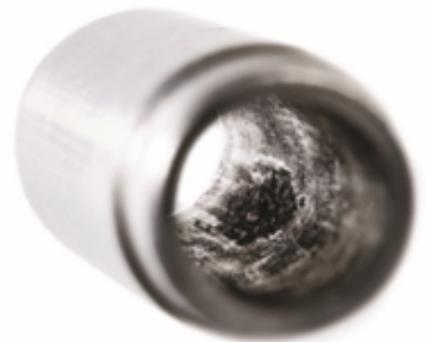
1.Excessive Valve Stem and Guide Wear

This can apply to both inlet and exhaust valves but, is probably more prevalent on exhausts. There can be many reasons for its occurrence and, expert advice is usually required. However, the most likely causes are:

- Incorrect stem to guide clearances, usually fitted with too much clearance, resulting in bellmouthing of the guide.
- Excessive carbon packing of the port end of the guide, leading to stem scuffing.

- Scoring and scuffing of the stem due to lack of oil or breakdown of the oil film.
- Abrasive wear from foreign bodies trapped between stem and guide, for example residual carborundum particles after overhaul.

- Temporary lack of coverage by the engine lubrication supply when starting a cold engine in sub-zero temperatures.
- Misalignment of valve guide to valve seat, resulting in high side loading.

- On rocker operated valves, excessive side thrust due to incorrect valve height after overhaul - i.e. valve heavily recessed due to too much metal removal from valve seat and face. Incorrect fitting of special high lift cams which affects the rocker geometry.

- A bent valve stem.
- A badly worn valve tip - this increases side loading.
