TECHNICAL REPORT

Ajusa New Product
EGR valve pipe

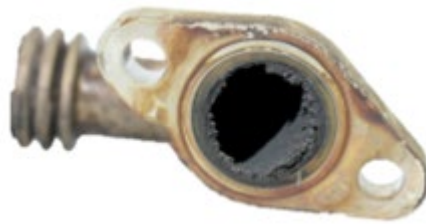
- **Carbon buildup:** Over time, the EGR pipe can become clogged with carbon deposits and other combustion debris. This can restrict the flow of exhaust gases, affecting engine performance and increasing emissions. A loss of power, increased fuel consumption, an unstable idle and possible error codes in the vehicle's diagnostic system would be the possible symptoms.

In this image you can see the **carbon obstruction of the EGR valve tube**. Its replacement is necessary to avoid future breakdowns and an increase in polluting gas emissions.

It is important to check the correct operation of the EGR valve and its sensor, to ensure that recirculation occurs at the right time and avoid future breakdowns. It is advisable to replace the pipe when these defects occur, as well as when the EGR valve is replaced due to obstruction.

Cleaning the pipe would not be enough, as there could be cracks that are not normally observed.
