Valve Face Wear

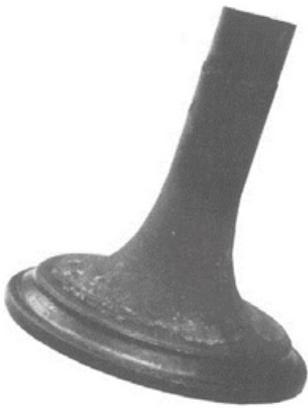
Exhaust Valve Face Wear

This does not usually effect modern engines. Engine manufacturers spot its occurrence during development, and correct it, typically by the use of a stellite seat. However, on earlier engines without hard faced seats valve face pounding and wear can occur. This is due to high engine temperatures, coupled with slack tappets or weak valve springs.

Before the use of non-leaded fuels and LPG, the products of combustion adequately lubricates the exhaust valve. However, the exhaust gases in these fuels are relatively dryer and lubrication free. This increases valve face wear; revision of valve geometry, valve and seat materials and cast iron head metallurgy prevents it

- High engine temperature coupled with excessive tappet clearance, weak valve springs etc.
- Valve to port seat misalignment.
- Engine operated on either low lead or LPG fuel (Petrol engines)

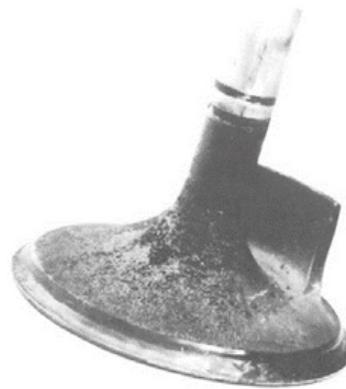
Inlet Valve Face Wear is specific to turbocharged diesel engines but not to turbocharged petrol engines. Turbocharging naturally increases the pressure during the induction stroke. However, it also increases air pressure in the inlet port to above atmospheric. This prevents the air stream carrying any lubrication oil from the valve guide. Consequently, the valve face and seat run dry. Wear can occur on either, though in practice mainly on the valve face.

Although similar conditions occur in the turbocharged petrol engine, the wetter fuel provides inlet valve and seat lubrication.

- Caused by "dry" valve seating resulting from high inlet port pressures and subsequent lack of lubricating oil mist drawn from the valve guide. Ensure to fit materials that are to the correct specification.
