SI 0083
For technical personnel only!
1/2

SERVICE INFORMATION

QUICK INSPECTION OF SECONDARY AIR VALVES

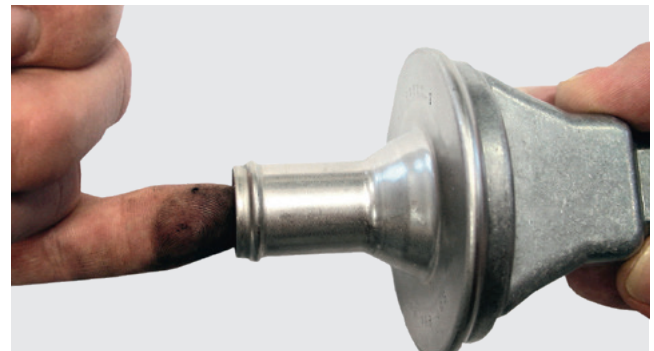
Fig. 1: Simple inspection of the non-return valve

- Loosen the connecting hose on the secondary air non-return valve leading to the secondary air pump.
 - See inspection point “P” on the graphic overleaf
- If there are deposits on this side of the valve (finger test, see Fig. 1), the nonreturn valve is leaky and must be replaced. In that case the secondary air pump may already have been damaged.
- Inspect the secondary air pump and replace it if necessary.

Damage as a result of exhaust gas condensate

The new condition as a comparison

The trigger for this damage remains in the vehicle and can lead to the recurrent failure of the secondary air pump. When replacing the secondary air pump, the electrical reversing valve and the secondary air valve must be inspected for leaks as a basic principle.

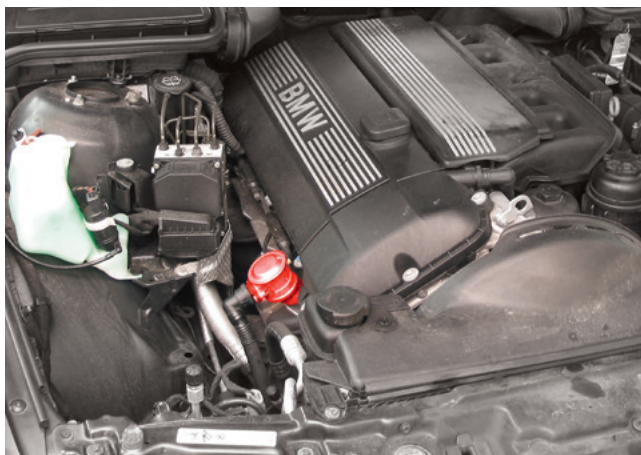
Two variants of the secondary air system

- 01 secondary air pump
- 02 electrical reversing valve (EUV)
- 03 switch-off non-return valve (approx. 1995 →)
- 04 secondary-air switch-off valve (approx. 1993 → 1997)
- 05 secondary-air non return valve (approx. 1993 → 1997)
- P inspection point for quick inspection

Secondary air valves are an integral part of the secondary air system. They are fitted between the secondary air pump (1) and exhaust manifold.

They prevent pressure peaks in the exhaust flow from damaging the secondary air system and exhaust gas or condensate from entering the secondary air pump. There are different designs of secondary air valves:

Switch-off non-return valves (3) are generally vacuum-operated valves. Later designs (from approx. 1998 →) are opened by the pressure of the secondary air.

This does away with pneumatic control by an electrical reversing valve (2).

Secondary-air non-return valves (5) open as a result of the pressure of the secondary airflow.

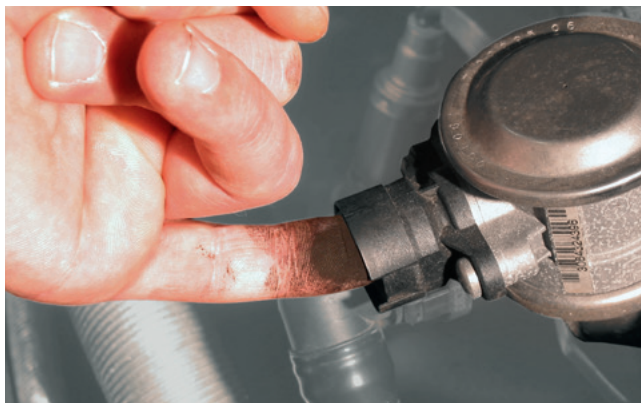
Quick inspection of the secondary air valve in the BMW 520i (highlighted)
