febi 193068 193076

To Fit: Porsche 911 (997) 2004 > 2013,
Boxster (987) 2004 > 2012,
Cayman (987) 2005 > 2013

Door Check Strap

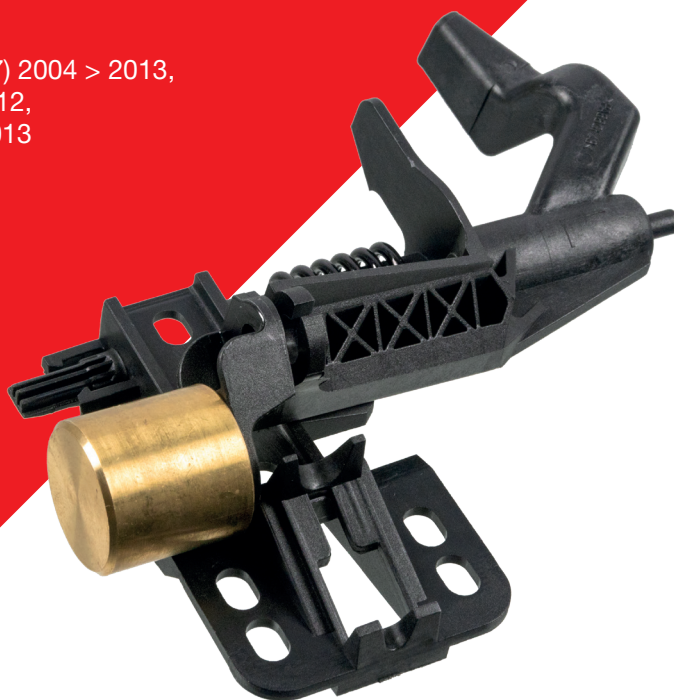
This door check strap - also known as a door lock pivot lever or interior door pull handle support - is located inside the door interior panel.

Being a highly used component that operates and flexes every time the door is opened, over time the plastic supports which restrain the spring weaken and break, resulting in the symptoms listed above.

Remove the interior door panel on the affected side. Undo the three T20 screws that retain the component to the door panel and inspect. Replace with febi part 193068 or 193076, check the operation of the door release handle, then refit the interior door trim panel. This will restore the interior door handle to being fully functional again.
