SWAG 10 92 1530, 10 92 7880

To fit:
Mercedes-Benz CLS-Class (219),
E-Class (211), SL-Class (230, 231)

Control Arm Bush

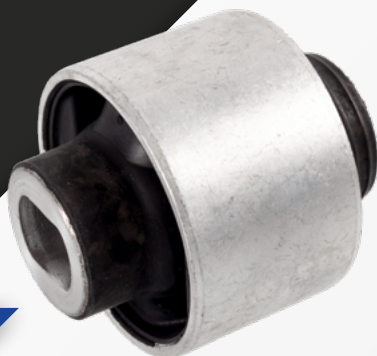
10 92 1530 (old implementation)

When repairing the control arm on any of the Mercedes-Benz models listed above, the replacement control arm bush is of a different design to the one that has been removed.

During the course of production of the Mercedes-Benz models listed above, improvements were made to the noise, vibration, and harshness characteristics of the suspension components. A new hydraulic control arm bush was developed to replace the original rubber metal design, however the manufacturer continued to offer both versions as service parts.

If the original bush that is removed from the control arm is the early rubber metal design, SWAG recommends installing the improved hydraulic version. If this is the case, SWAG suggests replacing both control arm bushes at the same time to improve the vehicle's noise, vibration, and harshness characteristics.
