Focus on Suspension

FRONT SUSPENSION

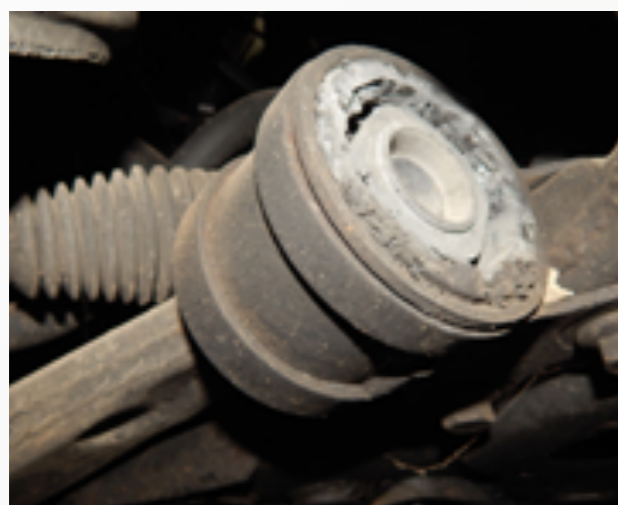
Fig. 1

One of the most common wear items on the MK 2 model is the track control arm bush, (Fig 1). This component is available as part of the complete arm or available as a separate part with new fixing bolts. The latter, is available from SWAG, and offers an economic repair of this component, compared with replacing the whole arm, which in most cases is perfectly serviceable.

When carrying out this replacement, the alignment of the new bush is very important. The bush needs to be aligned correctly on the shaft of the suspension arm for its correct operation and to ensure long life of the replacement component. The old bush can be pressed off or carefully cut off using suitable equipment, so as not to damage the shaft that the bush is mounted on.

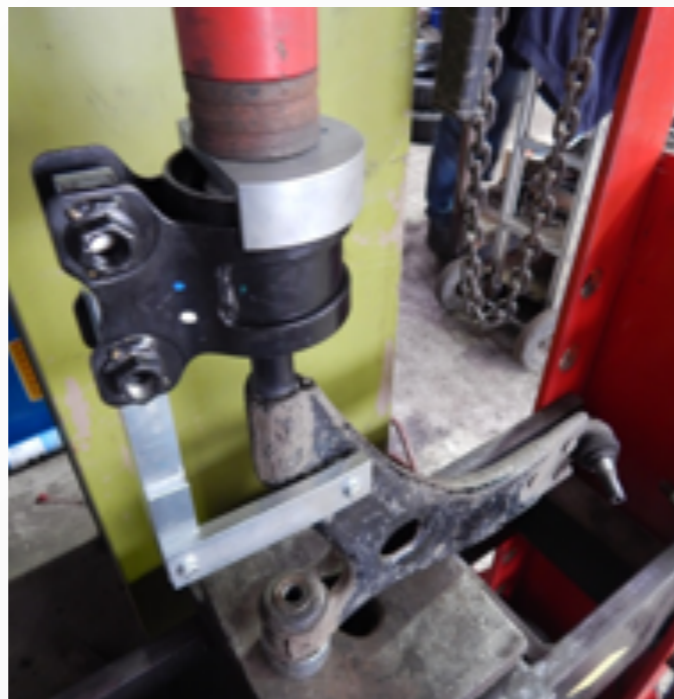
Fig. 2

Once the old worn bush is removed, clean the shaft, then the new bush should be pressed on; there is a special tool available

to maintain the alignment of this, while the new bush is being pressed into position. (Fig 2)

The repaired arm can now be refitted to the vehicle. The bush (SWAG 50 93 2418) has applications for several other Ford, Mazda and Volvo models.

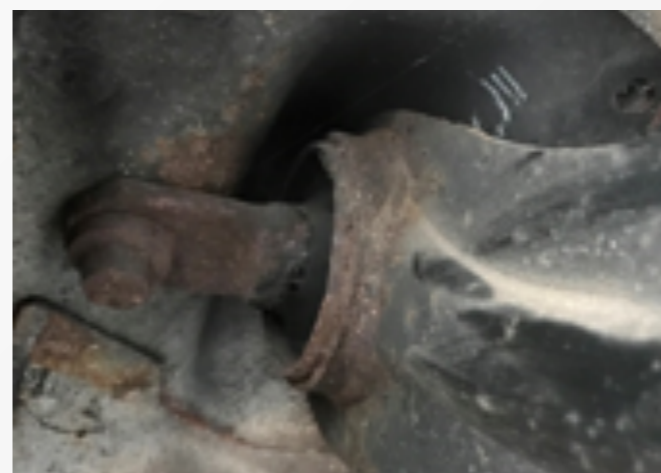
Fig. 3

The highly acclaimed control blade trailing arm multilink suspension system was developed for the Focus model; its compact design allows maximum use of space for luggage capacity and gives excellent handling. The thin trailing arm handles, fore and aft wheel location and brake-torque reaction, with three other links that are needed to fully locate the wheel. All these components have bushes that are prone to wear. The trailing arm bush (SWAG 50 93 4249), which is replaceable like the front control arm, needs to be aligned correctly during installation; otherwise the rubber will over twist and shorten the life of the bush. (Fig 3)

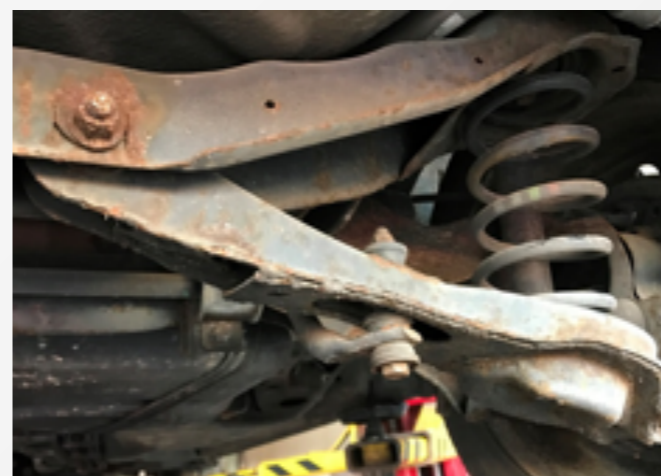
Fig. 4

The track control arm, which is located between the cross member and the knuckle, is prone to stress fractures which can lead to failure after long service. When this arm is

removed to gain access to other components such as the road spring, or when it needs replacing, the fixing bolts are prone to corrosion. (Fig 4)

This leads to the bolts shearing during removal or being seized to the bush inner sleeve. Therefore, it may be necessary to cut them off in order to remove the arm.

The inner bolt, which is an eccentric bolt, is for camber adjustment, it must turn freely if it is to be adjusted. It is recommended that all bolt fixings are tightened only when the vehicle's suspension is under load, not free hanging, as this puts unnecessary strain on the bushes and can lead to them being tightened in the incorrect position.
