# NEW PRODUCT HIGHLIGHT | JUL2022

## febi 177741

to fit:  
Mercedes-Benz Trucks  
Actros I+II+III, Atego I+II, Axor I+II

## Switchgear for Transmission

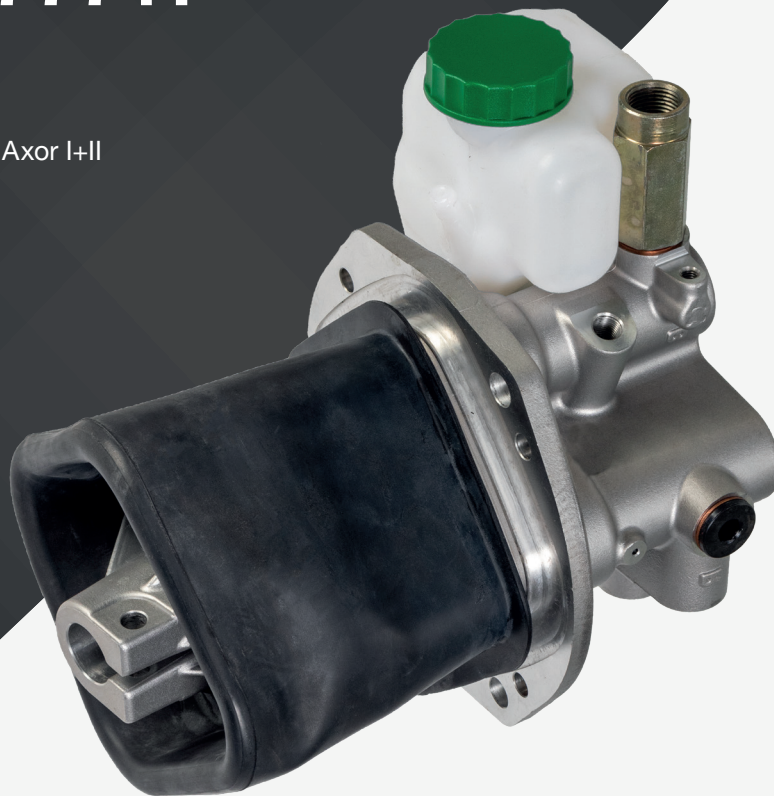
The switchgear is required to hydraulically actuate the shift valves on the transmission and thus be able to shift the gears in the transmission. It is located below the cabin and the shift lever is directly connected to it. Together with the shift valves on the transmission it forms a closed hydraulic circuit.

As the switchgear works hydraulically, only a completely vented system can fulfil its function correctly. The hydraulic circuit is often opened during transmission removal, for example when changing the clutch, in order to separate the components. In this case air can enter the circuit. If the system is not properly vented during assembly, it may not function correctly. In addition, if there is air in the system, the missing center position of the shift lever can cause the shift actuation to move to the left and right stops. This is where valves are located, which can be damaged. Repairs can be carried out using repair kit febi 178726.

Mineral hydraulic oil is prescribed as the operating medium for this switchgear. If brake fluid is used instead, the seals will be destroyed and leaks will result.
