# Blue Print ADB116106

To fit: Various Citroën, DS, MINI & Peugeot models

Engine: 1.4, 1.6 petrol

## Rocker Cover with vent valve and gasket

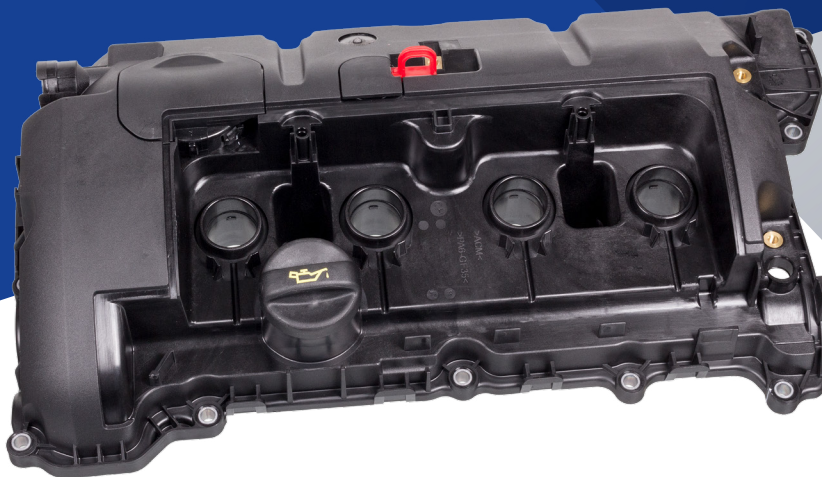
The radiator cooling fans run continuously after an engine service where the spark plugs or oil and filter have been replaced. Engine warning lamp illuminated and engine ECU fault code P0171 – Fuel Trim System Lean Mixture stored.

The engine management system (Motronic MEV.17.4) fitted to these vehicles activates the cooling fans at high speed as a protective measure when it detects a fault related to engine load or exhaust/emissions management.

This engine also has a specific design where it operates without traditional vacuum, instead the engine rocker cover and the oil filler cap are sealed from the environment.

Due to constant heat cycles in engine operation the sealing gaskets of the rocker cover deteriorate over time. There is also the possibility that the gasket sealing surfaces are disturbed during an oil change or repair, leading to the engine drawing in unmetered air from the environment. This can happen without noticeable noise or an unstable idle, making it harder to detect and diagnose.

A smoke leak tester can be useful to find and confirm these air leaks. Once diagnosed, replace complete rocker cover assembly with Blue Print ADB116106 - which includes new gaskets and seals - then clear and reset any fault codes relating to this issue.
