K SERIES GASKET and Shim Installation

THIS BULLETIN RELATES TO THE BGA HEAD GASKET CH9353M, AND HEAD GASKET SET HK6554UM.

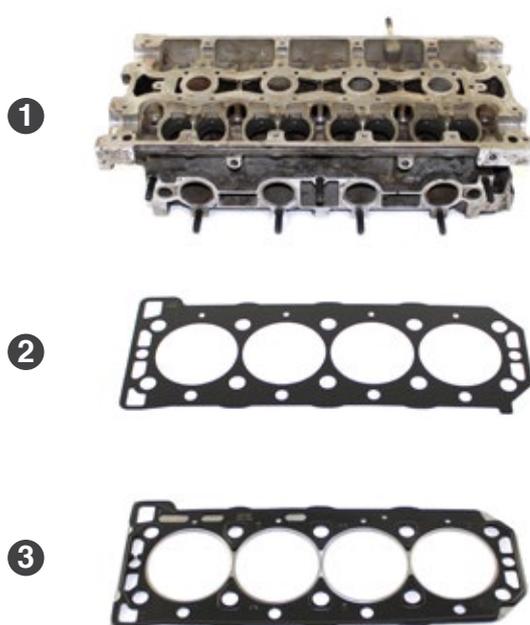
THE DIAGRAM BELOW SHOWS THE CORRECT PLACEMENT OF THE K SERIES GASKET AND SHIM.

- 1 Cylinder Head
- 2 Shim
- 3 Main MLS Gasket

- The Shim provided is placed above the Cylinder Head Gasket. This Shim allows movement during the thermal cycles, which prevents damage to the Cylinder Head surface.
- The BGA **CH9353M** Cylinder Head Gasket includes a Shim and is suitable for use on all K Series engines.
- Always replace the plastic dowels with steel ones, being aware not to damage the Cylinder Block surface.
- Please see the diagram to the right which identifies the correct placement of the Shim:
