## SWAG 50 10 9034

Ford Focus, Mondeo, C-Max, S-Max 1.6,  
1.8, 2.0, 2.2 Diesel Engines

## Injector nozzle for particle filter regeneration

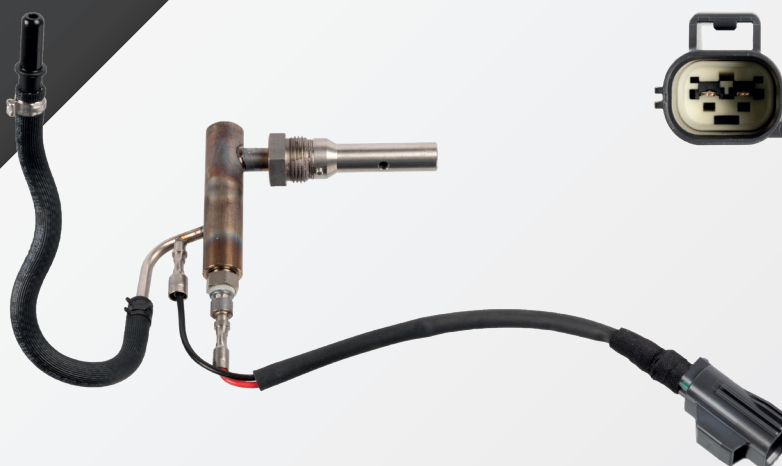
Poor engine performance and engine malfunction lamp illuminated, due to the diesel particulate filter being blocked and failing to carry out regeneration.

The Injector nozzle is physically blocked, or there is a blown fuse due to an internal short circuit caused by the injector nozzle glow plug overheating, or fuel supply pump failure.

Diagnose possible faulty exhaust injector nozzle, by connecting a hand held vacuum pump to the fuel line that supplies the nozzle, check if it holds a vacuum. If a vacuum is held, the injector is blocked and will need replacing.

If the fuse for the injector heater glow plug or pump has blown, then test the glow plug resistance. Nominal 1.1 Ohms, if it is less than 0.8 Ohms or greater than 1.3 Ohms then the injector glow plug is faulty, which is part of the injector unit.

If all values for the injector nozzle are within specification, check the condition of the fuel line supplying the injector and fuel supply. Then run the pump, if the pump is noisy, or does not run, check the wiring to the pump and make sure the fuel lines are not blocked. Replace any faulty parts as necessary.

After the repair has been carried out, a particulate filter service regeneration will need to be carried out in a well ventilated area.
